Living Coastal: Exploring Coastline Changes in Saint John, New Brunswick

ACAP Saint John 2022

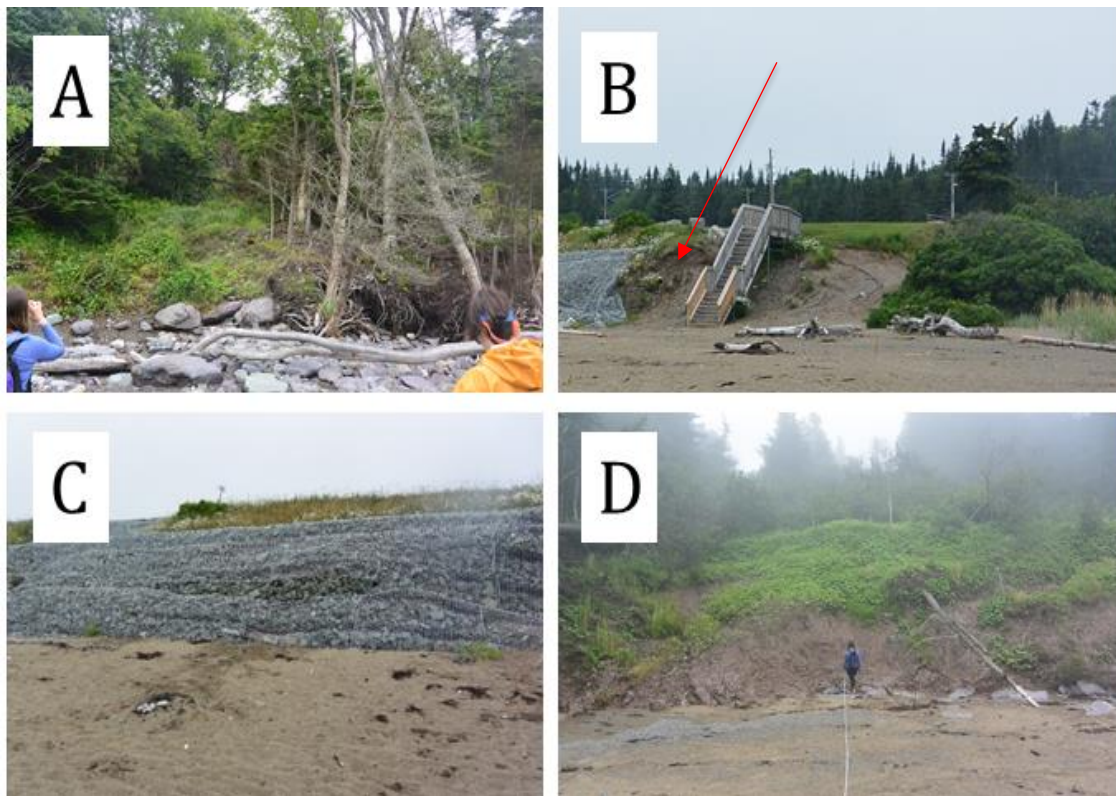
At the beach access point, the slope is steep, and a staircase is in place (Figure 9B). The staircase has been damaged in multiple storm events forcing visitors to walk down the adjacent slope accelerating erosion at the access point. During winter months the staircase is removed to avoid damage from winter storms. At the edge of the parking lot overlooking the beach, a slope has been partially reinforced with riprap to slow erosion from waves (Figure 9C). A full summary of observations is presented in Table 8.

Figure 9: Sites of erosion observed summer 2021 at Misphec Beach. (A) MB1 where fallen trees and debris are found on steep slopes. (B) Beach access at the end of MB3 showing the slope (58%) beside the staircase and the new material from repairs at the base of the the steps. Red arrow highlighting a culvert that outlets onto the backshore. (C) Riprap section in MB4 and MB5 where parking area overlooks the beach. (D) Successional slumping in MB7 where vegetation has grown on previously slumped material.

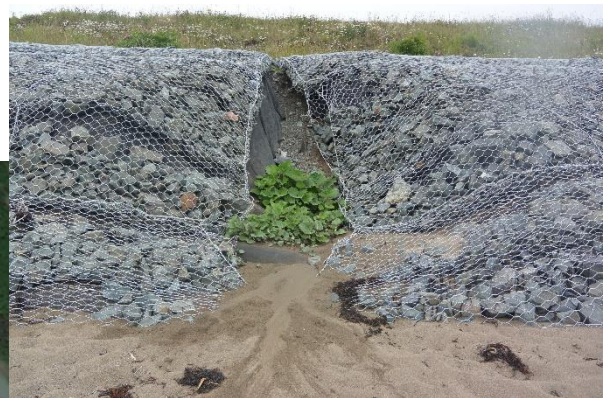
- Riprap and caging is used to stabilize MB4 and MB5. Tearing is noted and repairs may be required to maintain stability of this section (Figure 11).
- Partially stabilized areas have fallen trees and overhanging vegetation, but no active erosion was observed.
- Soil type is mainly sand over clay with loamy sand observed in some sections.
- Predominant form type is steep slope with a waterbody in MB3 where an unnamed brook outlets into the backshore (Figure 11). Smaller stream outlets are observed in MB5 and MB6.
- Anthropogenic installation of riprap in place in MB4 and MB5 and piping observed in MB5 (Figure 11).

Figure 11: Left, form types along Mispéc Beach observed summer 2021. Image above, showing a drainage channel in the riprap where repairs may be required.

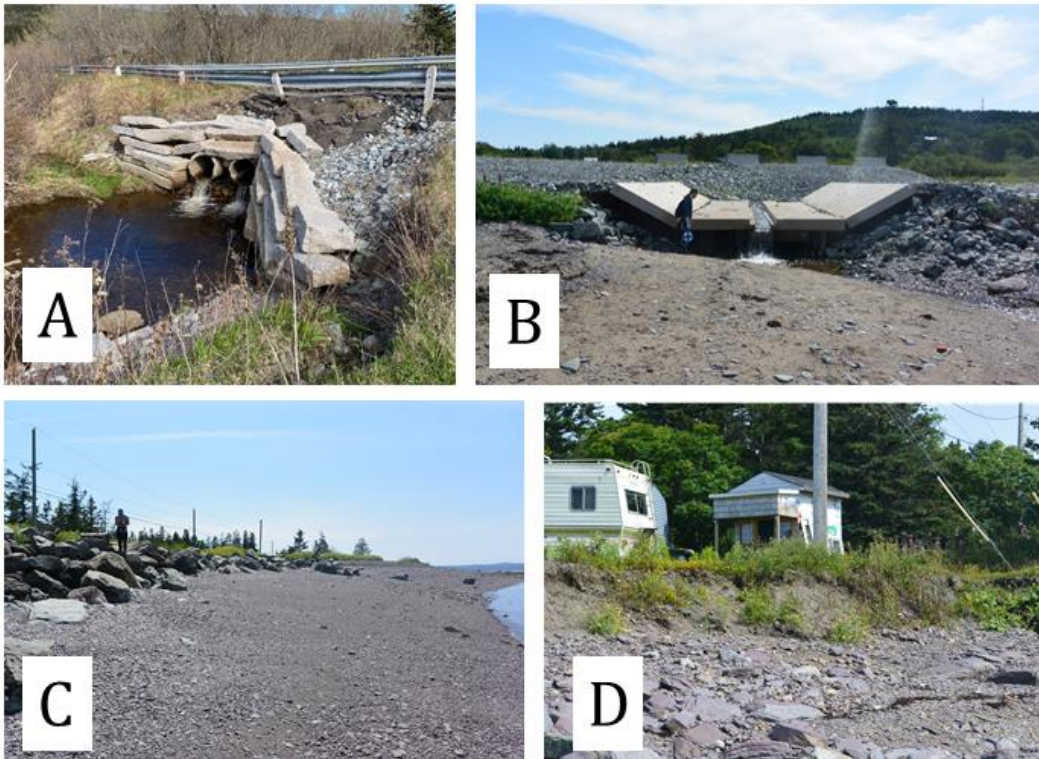
Figure 12: Example of form types at Anthony's Cove. (A) Anthony's Cove culvert in AC10 showing cracking of Anthony's Cove Road. (B) Bean Brook culvert in AC7. (C) Riprap protecting roadway ends in AC14 and begins again in AC17. (D) Erosion near utility pole at AC23.

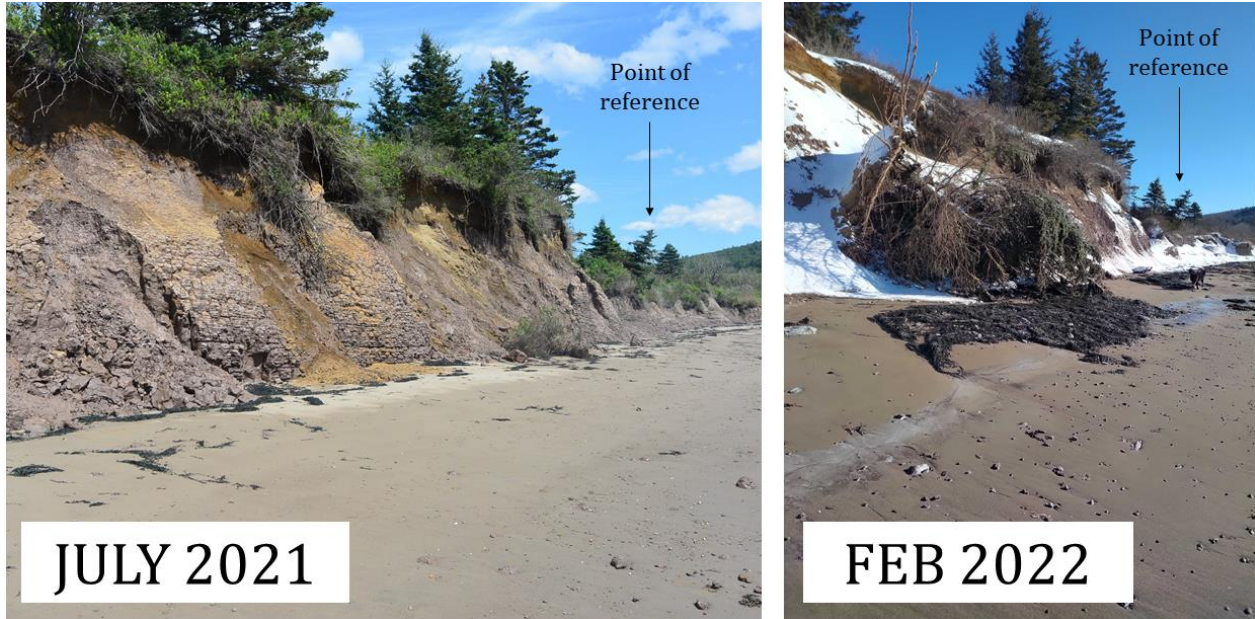
- High degree of variation in vegetation with a large portion of the coastline partially, mostly, or fully vegetated with grasses. Loss of vegetation due to erosion is observed (Figure 15).
- Engineered culvert at Bean Brook (end of AC6) and evidence of old culvert in AC7 (Figure 16).

Figure 15: Observed loss of vegetation in AC2 over the course of the project. Trees along the coast can be used as reference points to compare the images. The newly fallen tree in February 2022 can be seen intact during the site assessment completed in July.

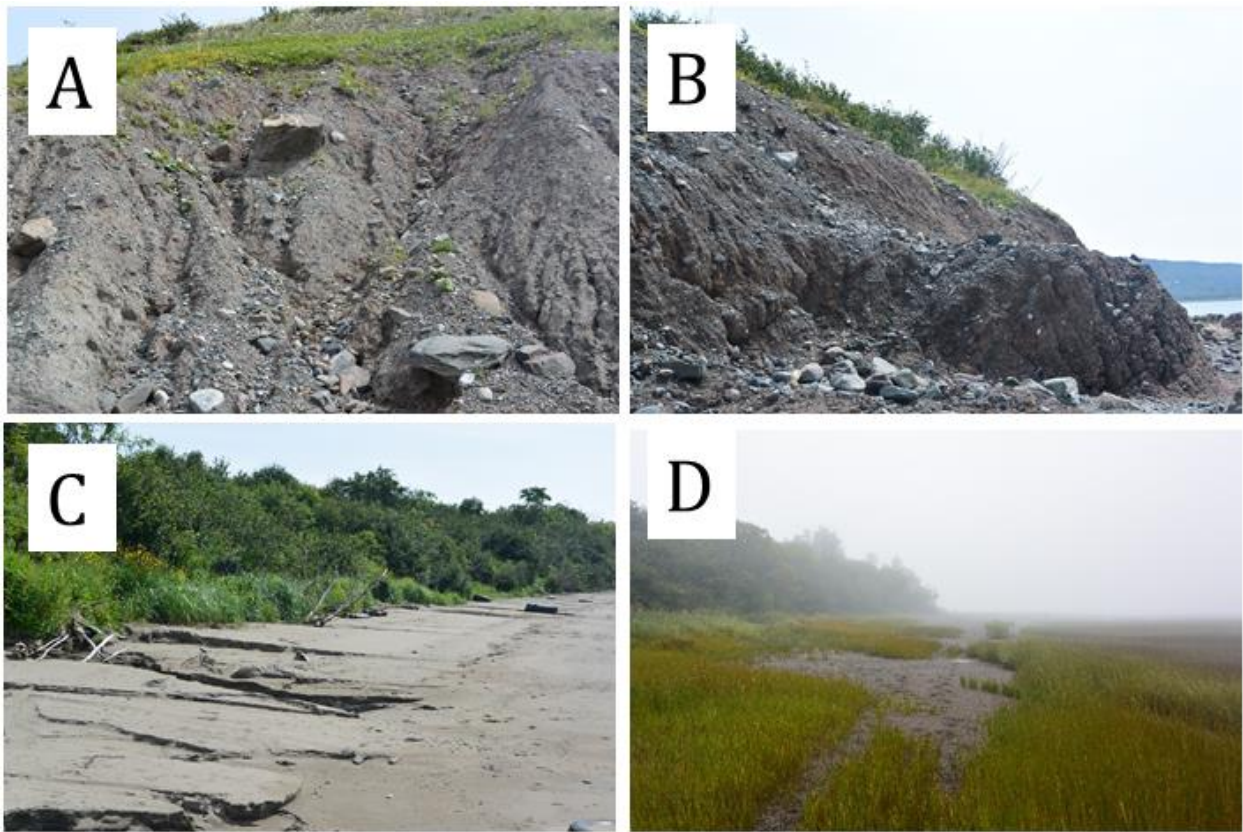
Figure 17: Observations of stability at Red Head. (A) Loose boulder material in RH2 where slope is not stabilized. (B) Slumped material in RH3. (C) Overland drainage channels in the backshore at RH22 where coastline is highly stabilized. (D) Vegetation in the backshore and foreshore at RH25.

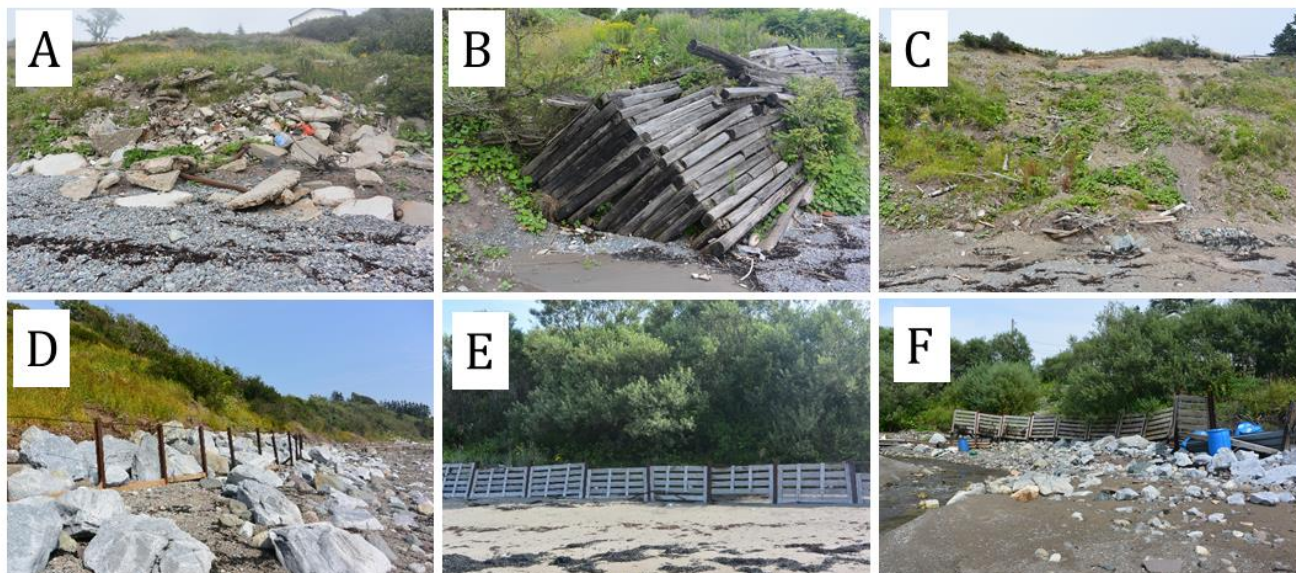
- Erosion is observed beyond installed protection suggesting that high water events have surpassed protective measures.
- Coastline is high from RH1-RH16 and then slowly declines toward Beyea Brook (Figure 21).

Figure 20: Debris and damaged protective measures at Red Head. (A) Debris along the slope in RH9 and a structure in the top right corner on the slope edge. (B) Damaged wooden seawall in RH10. (C) Additional debris scattering the slope in RH11 with structure at the top of the slope. (D) Protection in RH12 where riprap and seawall installments are ineffective to protect the coastline. (E) Coastal fencing in RH15, relatively intact and fully vegetated. (F) Damaged fencing with debris at RH20 alongside the outlet of Beyea Brook.

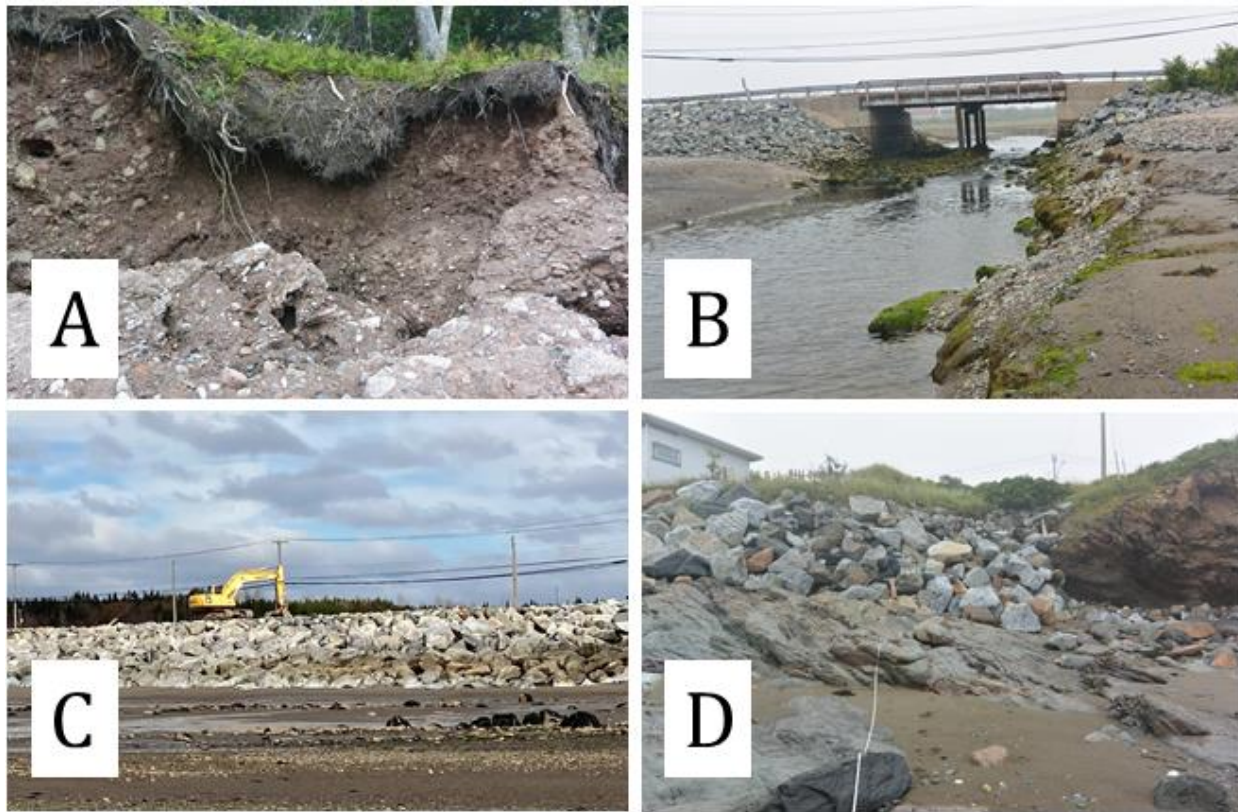
Figure 22: Observations of stability and key infrastructure at Hazen Creek. (A) Overhanging vegetation at HC5. (B) Bridge at Red Head Road crossing over Hazen Creek. (C) Maintenance of riprap in November 2021. (D) Home (left) at HC14 where some riprap is observed along with bedrock outcrops in the backshore and on the right.

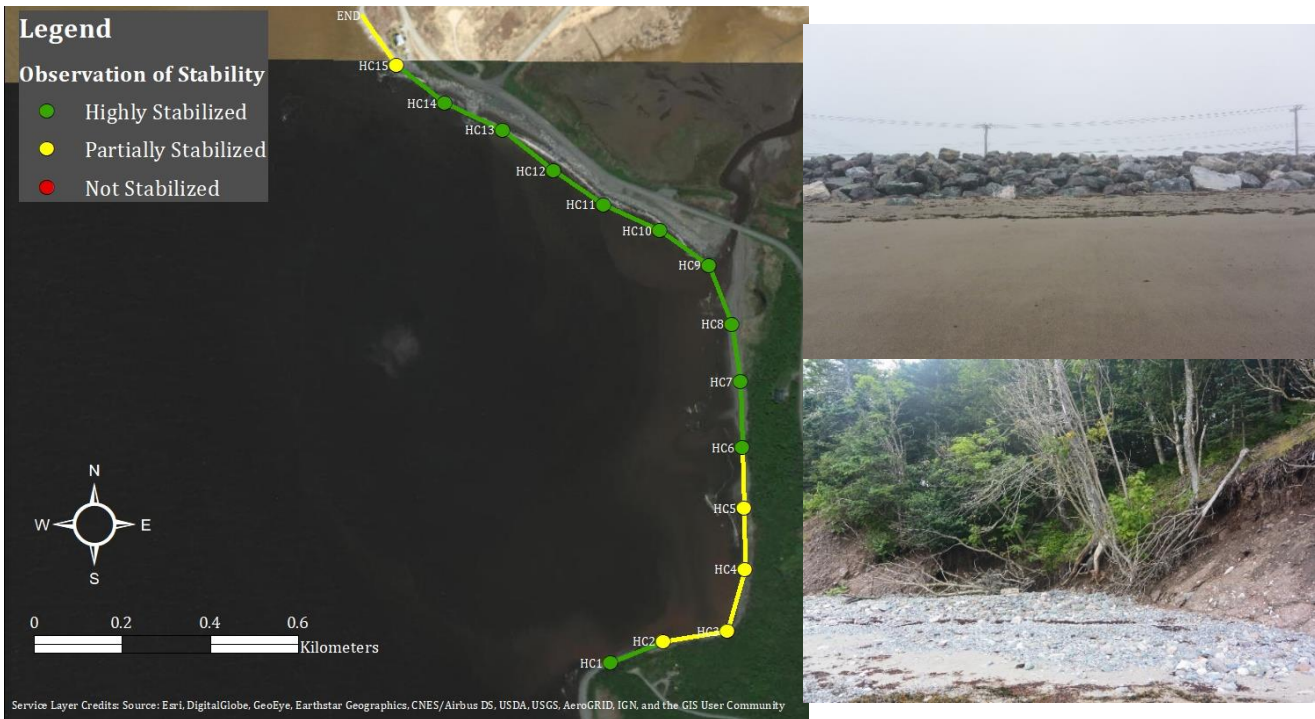
Figure 23: Observation of stability at Hazen Creek in summer 2021. Images: Top right, riprap and powerlines observed in HC13. Bottom right, trees falling from slopes in HC6. Both images show the highwater mark, resulting in a reduced backshore along the coastline.

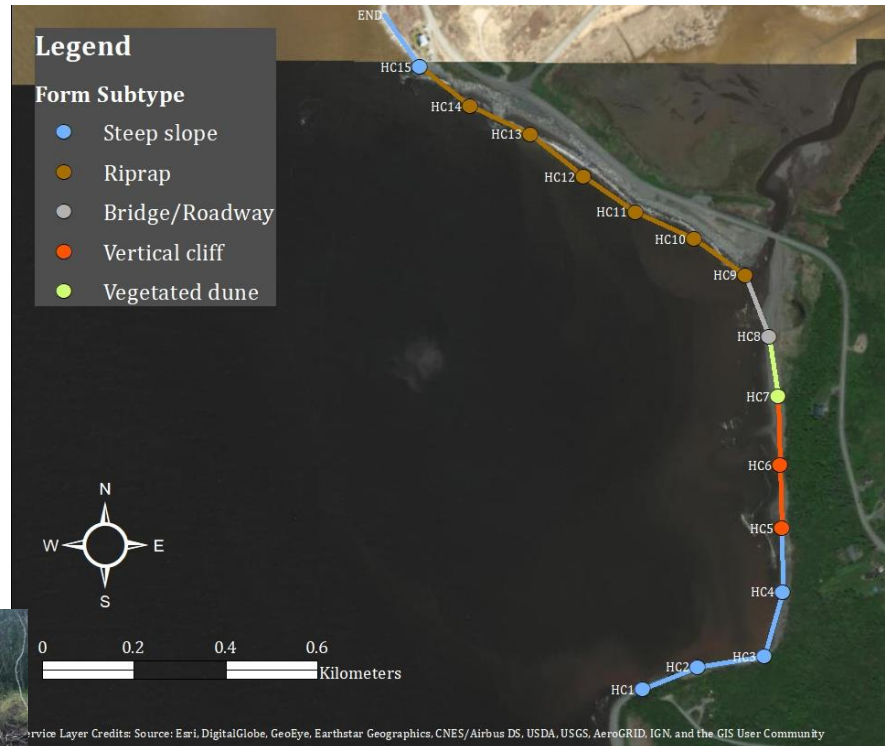
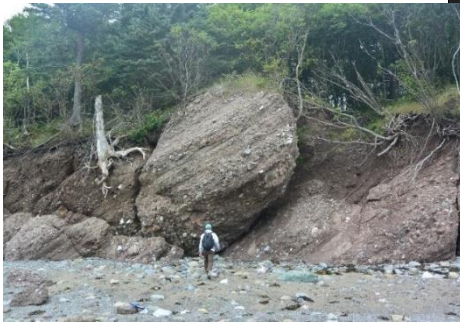
Figure 25: Form types observed at Hazen Creek during summer 2021. Image left, exposed bedrock material in HC5 with falling trees and overhanging vegetation.

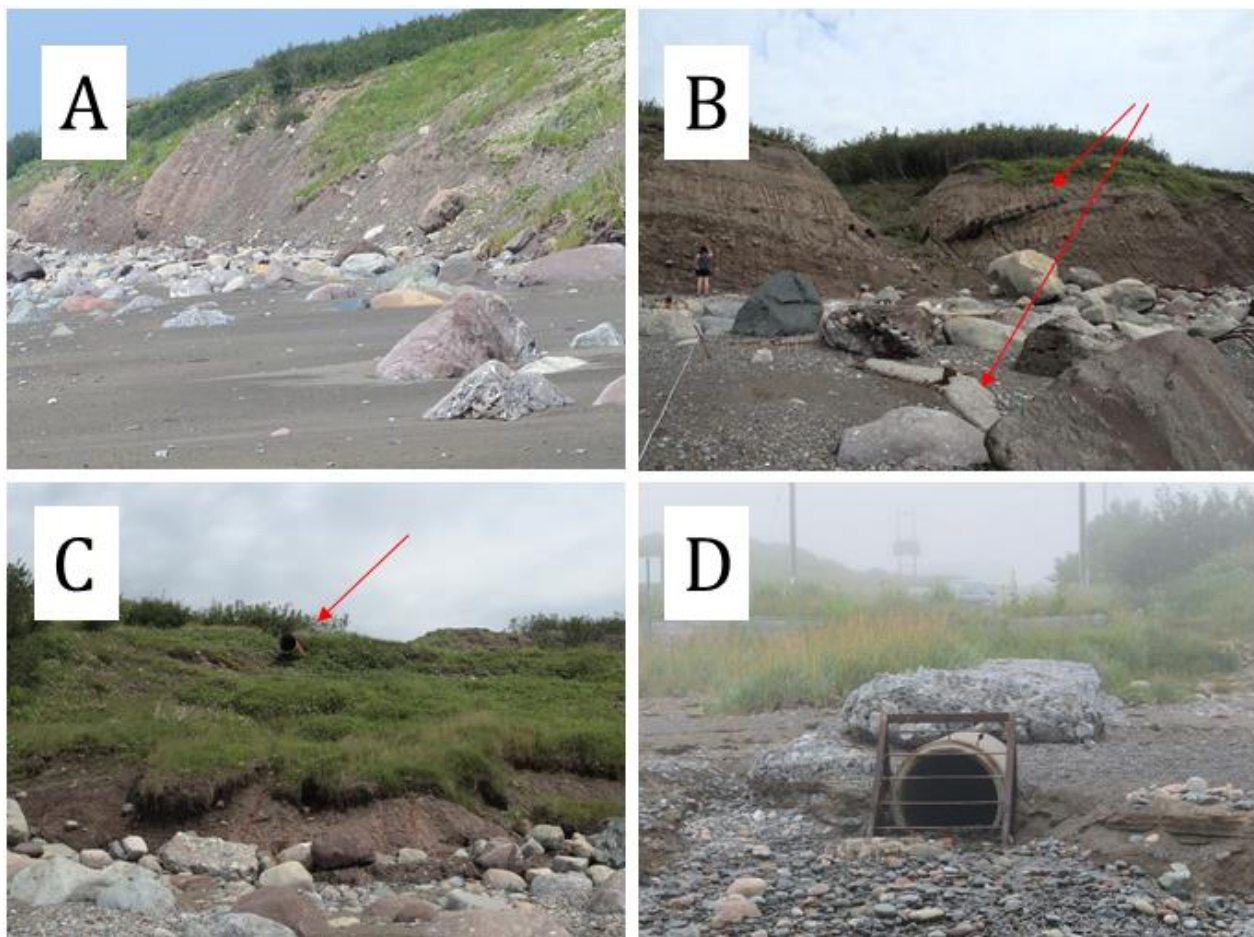
Figure 27: Highlighting form types and infrastructure at Bayshore Beach observed 2021. (A) Steep slope in BB3 with many boulders observed in the backshore. (B) Infrastructure and debris along the coastline and backshore in BB5. (C) Piping outlet at BB6 with vegetated slumps observed along the slope. Overhanging vegetation at the base. (D) Stormwater outlet and gabion support structures in BB11.

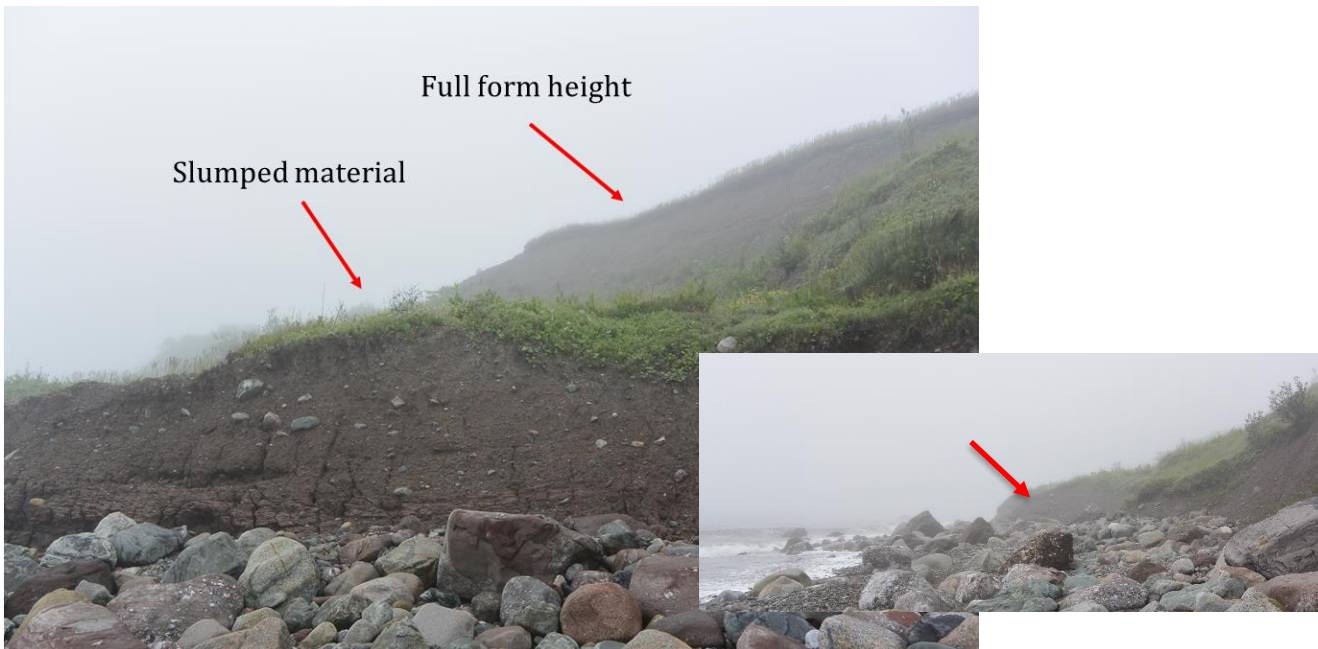
Figure 29: Left, large slump in BB7. Drainage channels are observed on the exposed slopes. Vegetation has grown on the slumped material. Right, material is blocking a section of the backshore creating a carrier to the beach during high tide. Note, many boulders in the backshore and along the shoreline.

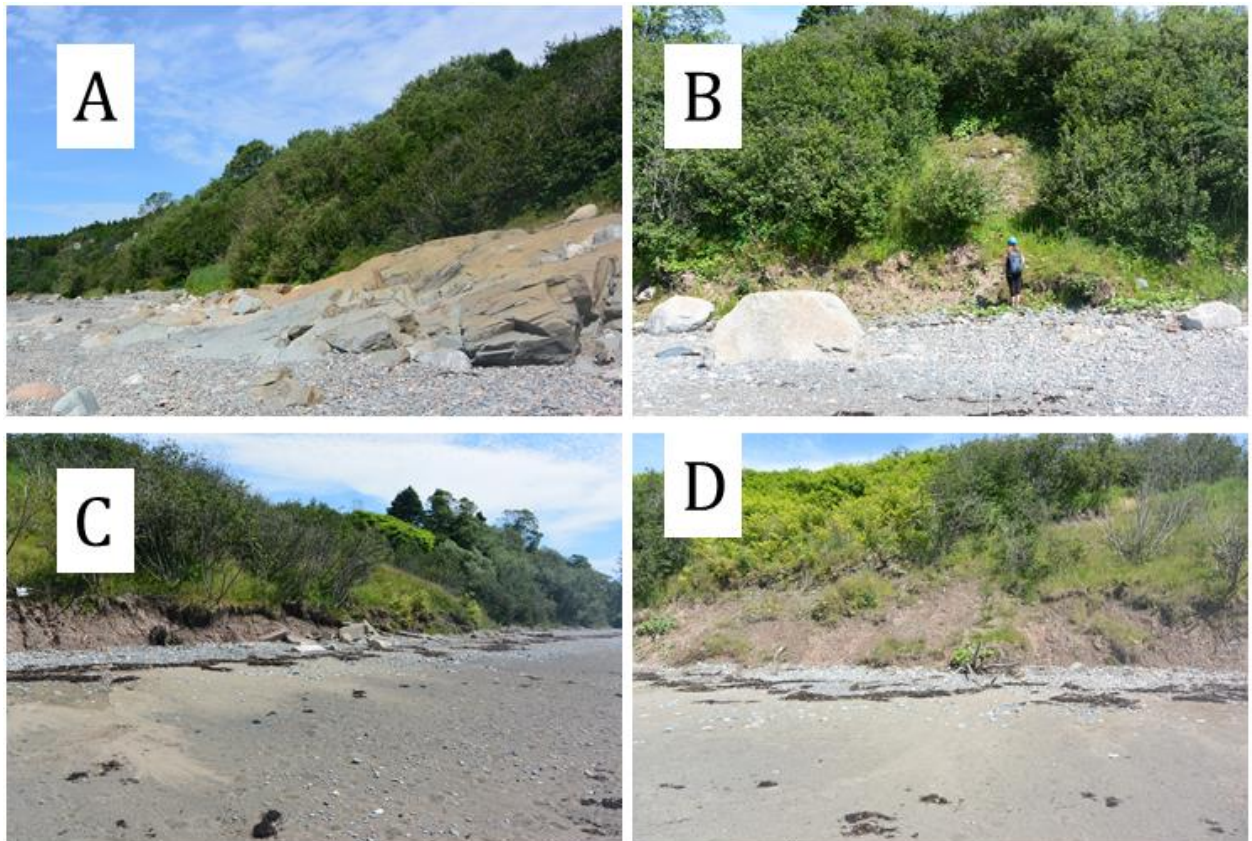
Figure 31: Highlights of erosion and form type at Duck Cove observed 2021. (A) Bedrock at DC1 looking west down the coast. (B) Steep slope in DC3 with shrubs as the dominant vegetation. Note the gap in vegetation where erosion is observed. (C) Debris at the base of the slope in DC3. Erosion from wave action and overhanging vegetation is observed. (D) At the end of DC3 before the height and erosion of the slope increase at DC4. The slope is mostly vegetated with erosion at the base. Note the shoreline washup in both (C) and (D) at the base of the slope.

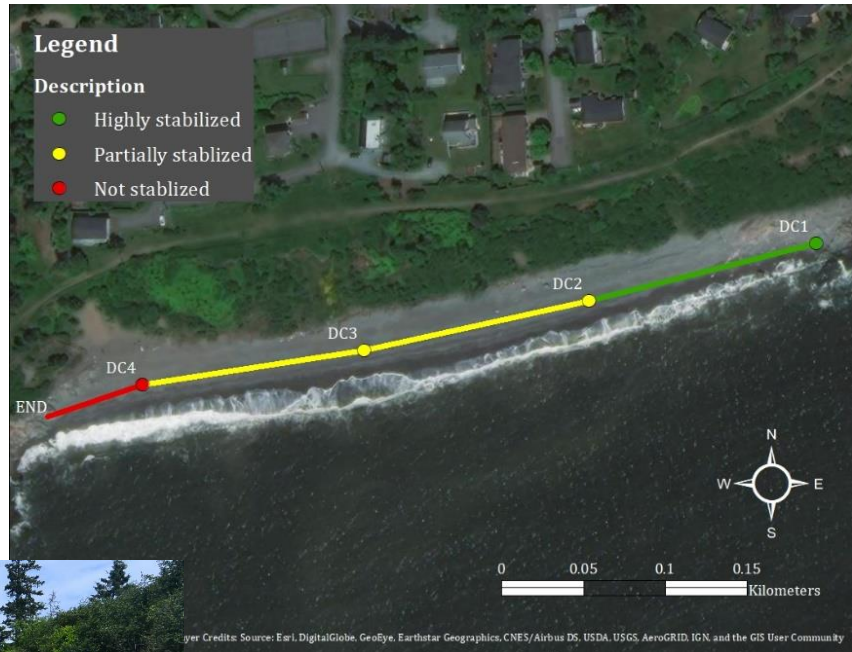
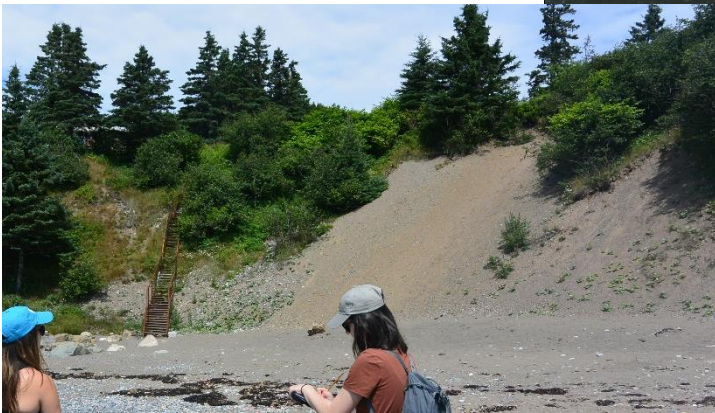
Figure 32: Observation of stability at Duck Cove summer 2021. Image left: Eroded section at DC4 where coastline is not stabilized and sand is the predominant soil texture. Staircase access is on the left where vegetation returns but erosion is observed around the access point.

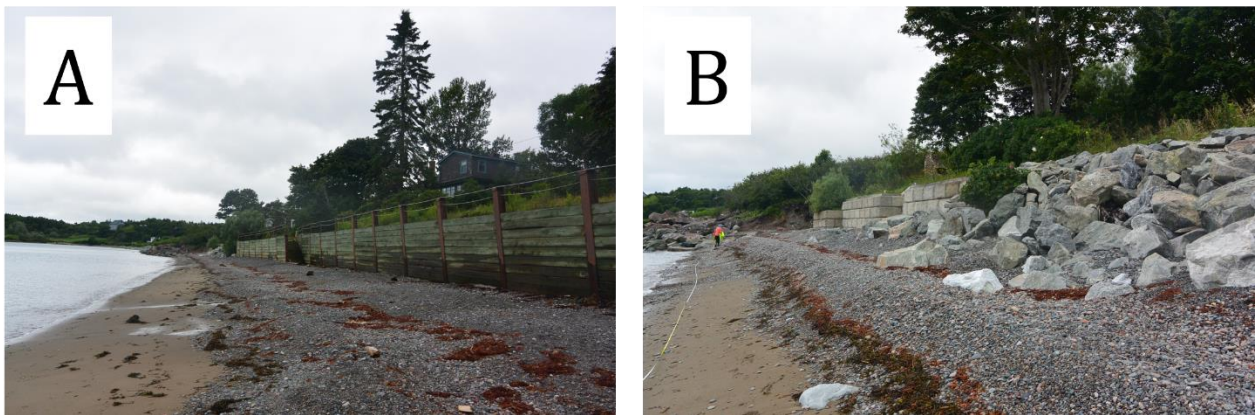
Figure 34: Images (A) Wooden seawall in MCB4. Staircase shows signs of wave damage and wall is angled towards the shoreline indicating erosion is occurring beyond the protection. (B) Concrete seawall and riprap in MCB5 to protect homes.

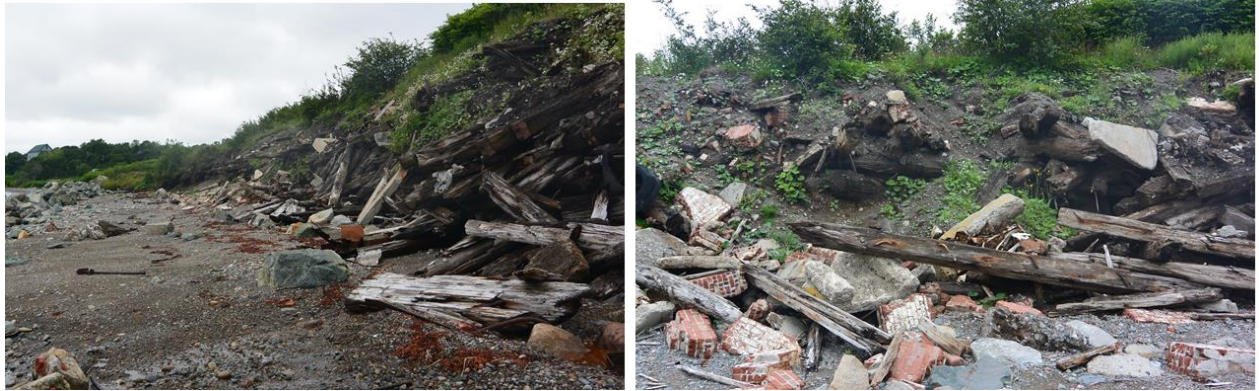
Figure 36: Image left, MCB6 looking southwest where debris is covering the slope. Right, debris in MCB6 could be from old infrastructure or infill used to extend and protect the coastline. Riprap observed along the shoreline leaving a gap between the water and debris.

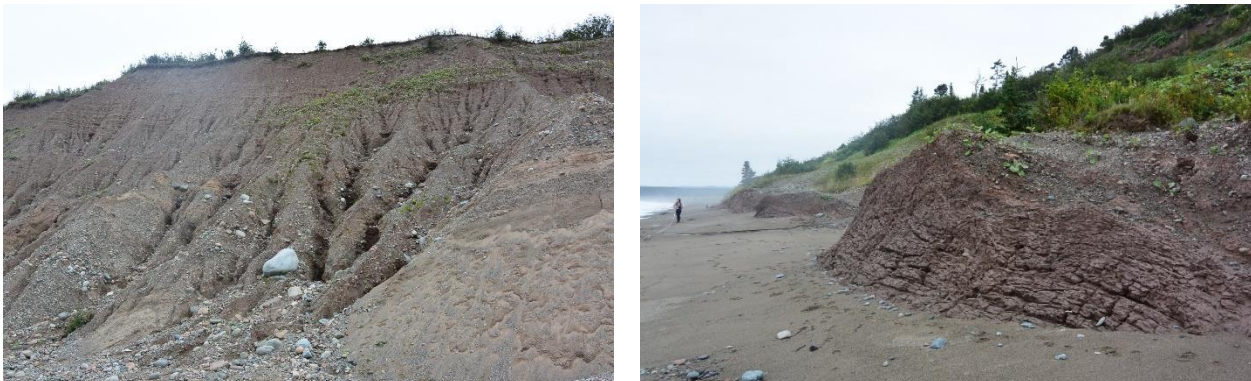
Figure 40: Images: left, drainage channels and loose boulder material in SP10. Soil layers visible at the top of the slope. Right, multiple slumps in the backshore at SP11.

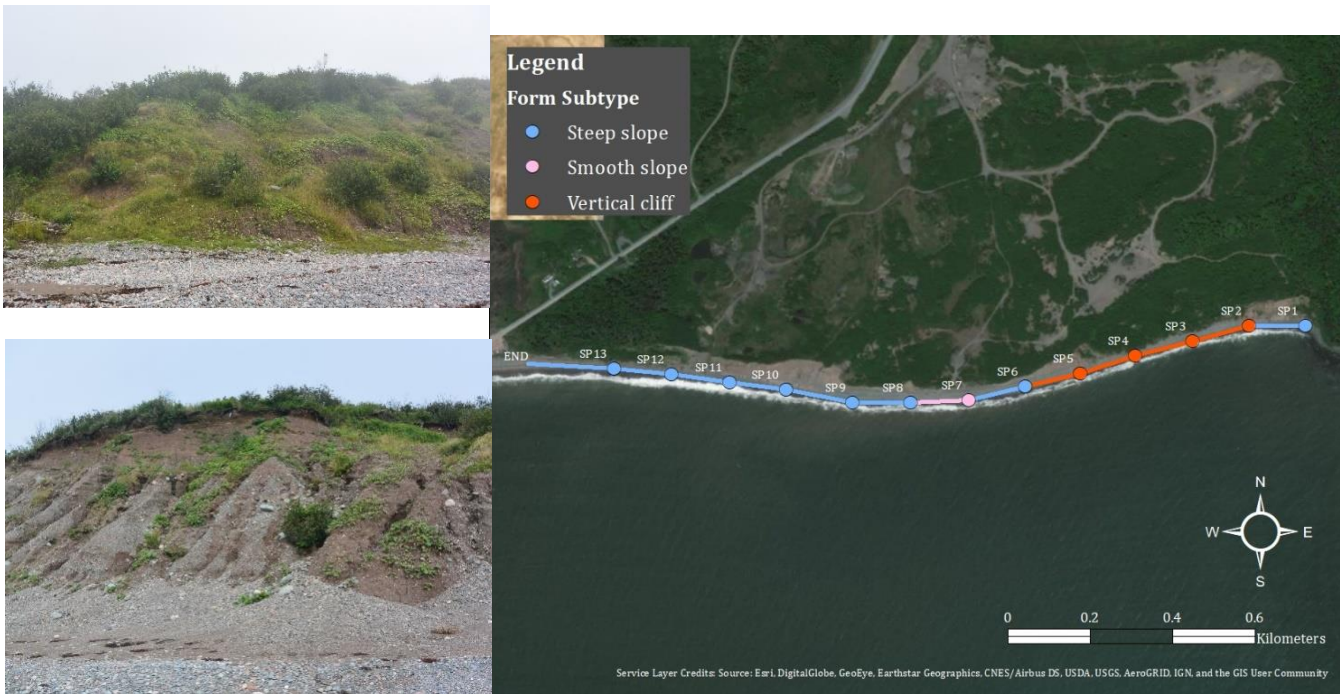
Figure 42: Form types observed at Sheldon Point in summer 2021. Only one section is categorized as a smooth slope. Images left: Top, in SP2 vegetation, predominantly grasses have grown onto the cliff face. Bottom, drainage channels and overhanging vegetation on a steep slope in SP5.

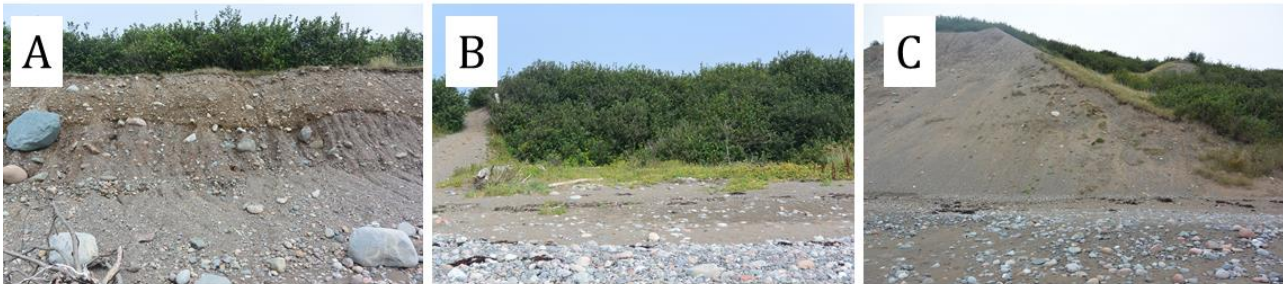
Figure 43: Observations throughout Sheldon Point. (A) Changing soil layers and fallen boulders in the backshore at SP6. (B) Trail access point in SP7 is mostly vegetated and predominantly sand. (C) Increase in form height and vegetation in SP9. Loose material is highly vulnerable to erosion from runoff.

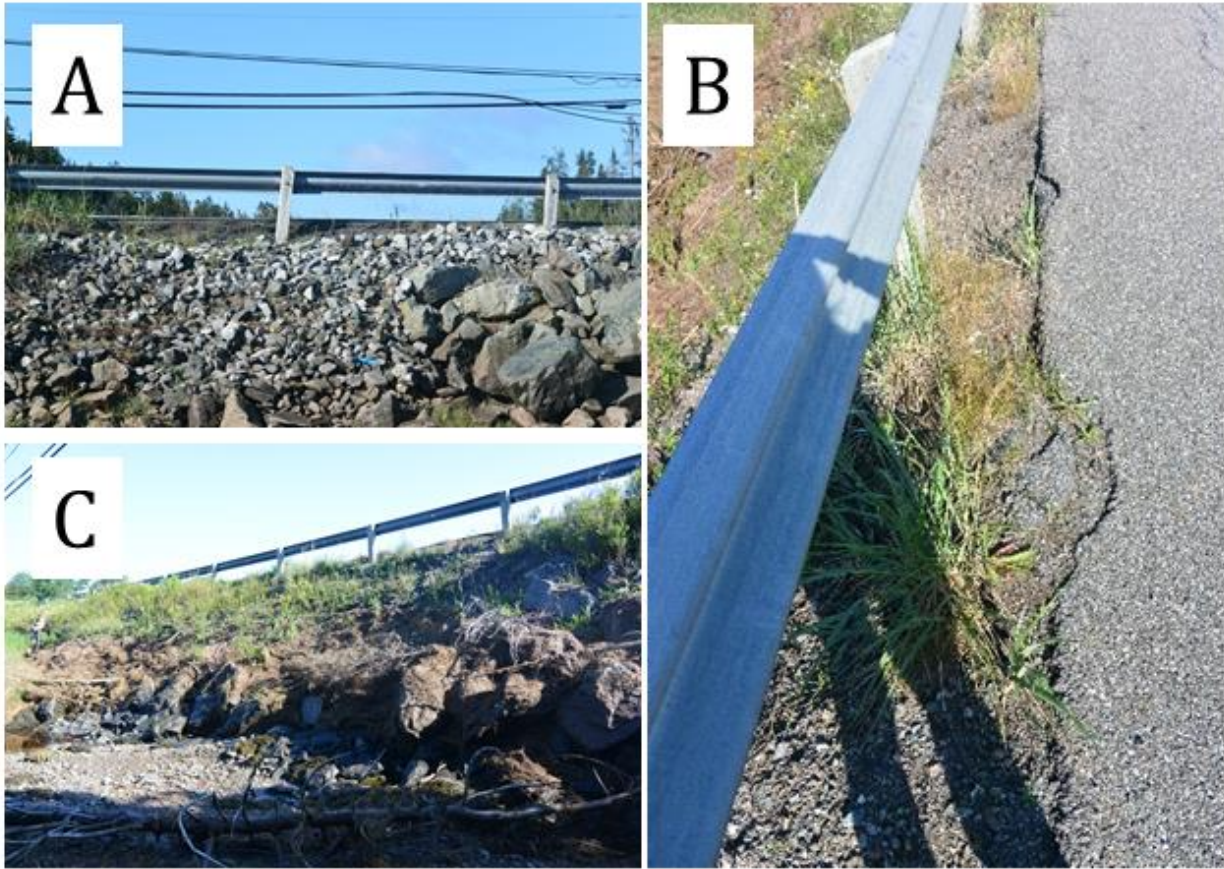
Figure 46: Highlights at Lorneville Cove 1 at the Lorneville Community Centre. (A) Erosion at the road shoulder in LVCC1. (B) Road buckling along the guardrail of Lorneville Road. (C) Debris built up over riprap in LVCC2 blocking a culvert from flowing below the roadway.

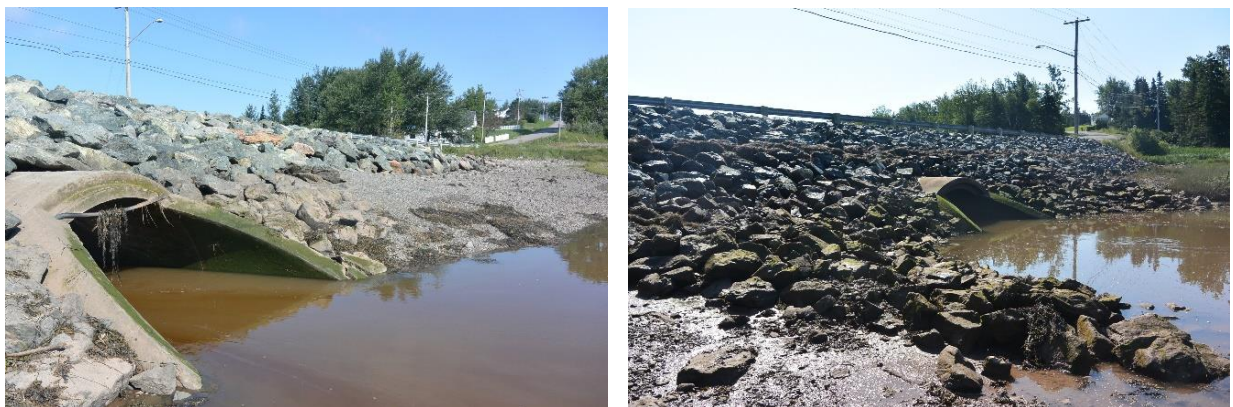
Figure 48: Images: left, culvert at LVPO1 on the coastal side of the roadway. Bottom, at LVPO2 on the inland side. Culvert appears to be in good condition.
