Rebirth of Water 2018-2019

Jeong, Sungmin Moore, Leanne Stewart-Robertson, Graeme

2019

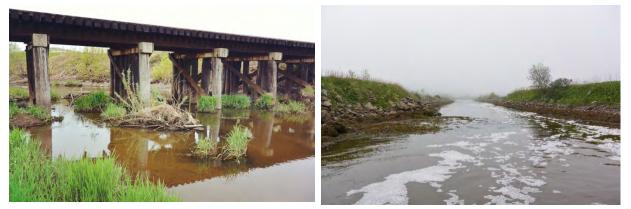
Figure 3. Sites 1 (right) and 5 (left) used in Water Quality Analysis B conducted in Marsh Creek.

Analysis B, which has acquired water quality measurements since 2012, incorporated five sampling stations located approximately 500 m apart within the last 2 km of Marsh Creek (Figure 2b). The stations included two sites in the Courtenay Forebay and three sites above the upstream site from Analysis A. The characteristics of the five individual sampling stations used in Analysis B are provided in Table 1 and Figure 3.

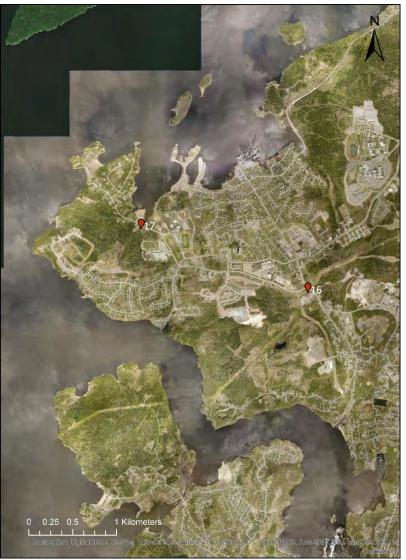
Figure 8. Map of the water quality monitoring sites, site 16 (upstream) and 17 (downstream) in Caledonia Brook.

Within the Caledonia Brook watershed, two sampling sites were established in 2017 to represent an upstream downstream comparison (Figure 8).

Site 17, Caledonia Brook downstream, (45.29687, -66.11867) was located just upstream of the culvert crossing at 159 Ragged Point Road.

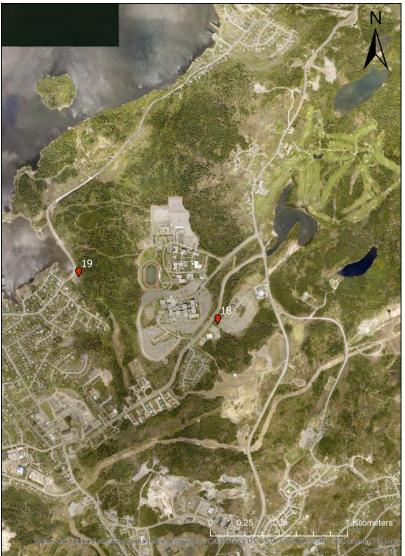
Figure 9. Map of the water quality monitoring sites, site 18 (upstream) and 19 (downstream), within the Alder Brook watershed.

Two sampling sites were established in the Alder Brook watershed in the 2017 field season (Figure 9).

Site 19, Alder Brook downstream, (45.30461, -66.09453) was located upstream of the culvert flowing into Brother Cove (outlet of Alder Brook) at 242 Kennebecasis Drive.

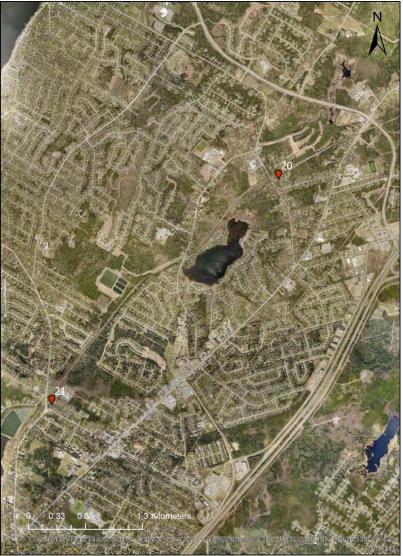
Figure 10. Map of the water quality monitoring sites, site 20 (upstream) and 21 (downstream), within the Salmon Creek watershed.

The two sites established in the Salmon Creek watershed were chosen to represent an upstream downstream comparison in the 2018 field season (Figure 10).

Site 21, Salmon Creek downstream (45.40077, -65.9918), was located within Salmon Creek off of Salmon Crescent where it meets Clark Road.

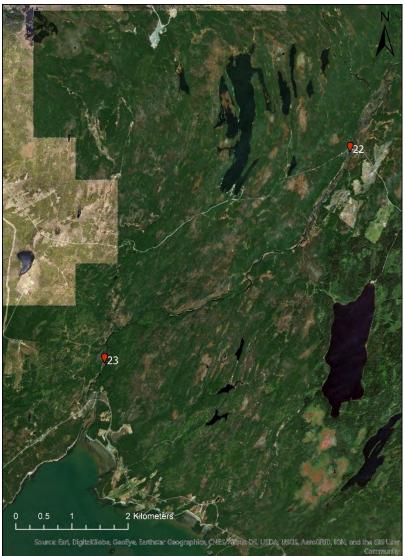
Figure 11. Map of the water quality monitoring sites, site 22 (upstream) and 23 (downstream), within the Mispec River watershed.

Site 22, Mispec River upstream (45.26938, -65.89505), was located downstream of a bridge crossing along Old Black River Road; approximately 5.33 km down the dirt road (Figure 11).

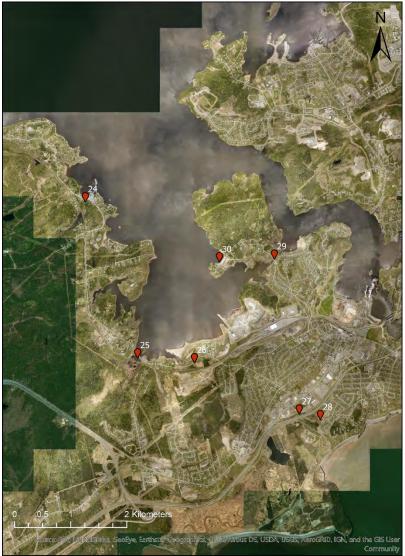
Figure 12. Map of the new water quality monitoring sites, sites 24-30, added during 2018 located on the Westside of the City of Saint John.

During the 2018 field season, seven new sampling sites were added to represent the water quality of the city's Westside. The locations of each sampling site can be found in Figure 12, and the characteristics of each sampling site can be found in Table 2.

Site Number	Stream Name	GPS Coordinates	Site Description
24	Mill Creek	45.27860 -66.15567	Located off the Westfield Road across the street from the Saint John Marina.
25	Spruce Lake Stream	45.25356 -66.14397	Located on the left-hand side of the street (Westfield Road) heading West; head down the embankment and sampling occurred near the culvert.
26	Walker Creek	45.25276 -66.13110	Located on the left-hand side of the street (Bay Street) heading west; head down the embankment and sampling occurred near the culvert.
27	Manawagonish Creek (Downstream)	45.24445 -66.10737	Located off of Fairville Boulevard near the Comfort Inn parking, turn into the MelMart parking lot and park towards the end. Head down the embankment until the creek is reached.
28	Manawagonish Creek (Upstream)	45.24355 -66.10259	Located off of Honeysuckle Drive, a weir is located on the outside of the street. Water was sampled 100 m upstream of the weir.

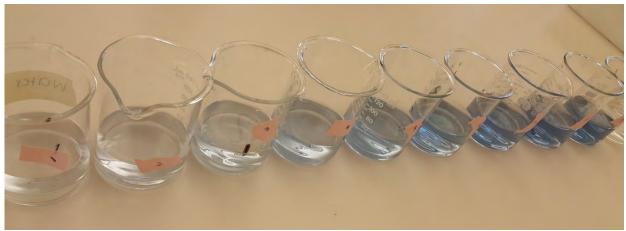
Figure 13. The colour development of standards for the orthophosphate calibration curve.

The beakers were swirled for proper mixing and left for 10-30 minutes to allow colour development (Figure 13). The absorbance and transmittance were recorded for all 10 beakers. The absorbance and standard concentrations were plotted using Microsoft Excel to generate a calibration curve (Appendix A). With this curve, the absorbance values recorded from the water samples were converted into concentrations in mg/L following equations provided in Appendix B.

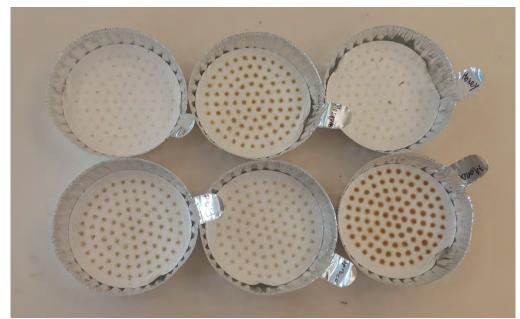
Figure 14. Image showing solids left on filter paper after filtration was completed using the Total Suspended Solids procedure.

Total suspended solids (TSS) were determined through the vacuum filtration method. A glass fiber filter disk (Whatman Grade 934-AH Circles 55mm) was rinsed three times with 20 mL of deionized water and filtered via vacuum filtration. The filter disks were placed in an aluminum weigh dish and into an oven at 105°C for one hour. The filters and aluminum weigh dishes were removed from the oven and cooled to room temperature in a desiccator. The weights were measured and recorded, then returned to the oven for a minimum of 20 minutes. The filter and weigh dish were returned to the desiccator and weighed once at room temperature until a constant weight was achieved (± 0.0003). Water samples (100 mL) were through filtered through the vacuum filtration apparatus, prior to rinsing the filtration apparatus three times with deionized water to ensure the entire sample had passed through the pre-weighed disks (Figure 14). The filters and associated weigh dishes were then dried/desiccated, as before, and re-weighed. TSS in mg/L was calculated based on the difference in weight (equation can be found in Appendix B) and results were recorded.

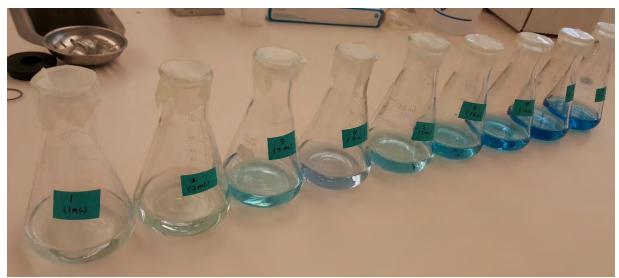
Figure 16. The colour development of standards for the Ammonia calibration curve.

To determine the ammonia concentration, a calibration curve (Appendix A) was constructed to represent the ammonia concentration in mg/L. A stock solution was prepared by dissolving 3.819 g of dried ammonium chloride in 1000 mL of deionized water volumetrically. This produces 1000 mg/L of NH₃N solution. A standard ammonium solution was prepared by diluting 1 mL of 1000 mg/L stock NH₃N solution into 100 mL of deionized water volumetrically to produce a 10 mg/L NH₃N solution. Continuing the serial dilution, 25 mL of 10 mg/L NH₃N solution was then diluted in 250 mL of deionized water volumetrically to prepare 1 mg/L NH₃N solution. This diluted standard solution was pipetted in amounts of 25, 20, 15, 10, 5, 4, 3, 2, and 1 mL into a 125 mL Erlenmeyer flasks and topped up to a final volume of 50 mL. Standards were treated as samples in the above procedure and placed into a dark space for one hour. Percent transmittance, at 640 nm, was then measured and recorded (Figure 16). Absorbance versus Ammonia concentration was plotted to make a straight line passing through the origin to create the equation needed to calculate ammonia concentration (Appendix B) in collected samples.

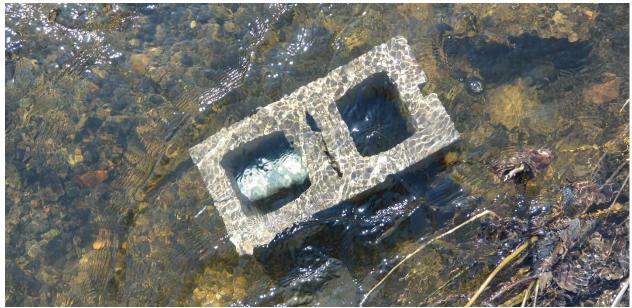
Figure 17. Example of temperature logger attached to a cinder block. All cinder blocks were covered underwater.

In addition to bi-weekly water quality sampling, the variation of water temperatures throughout the sampling season were analyzed at various watercourses using temperature loggers (EasyLog USB logger, EL-USB-1 model). The loggers were attached to cinder blocks and placed in various watercourses at the beginning of April 2018 (example in Figure 17). These loggers were left to collect data for seven months and were removed at the end of October.
