# TREE INVENTORY

FOR  
SOUTH CENTRAL  
PENINSULA,  
LOWER WEST SIDE  
& NORTH END

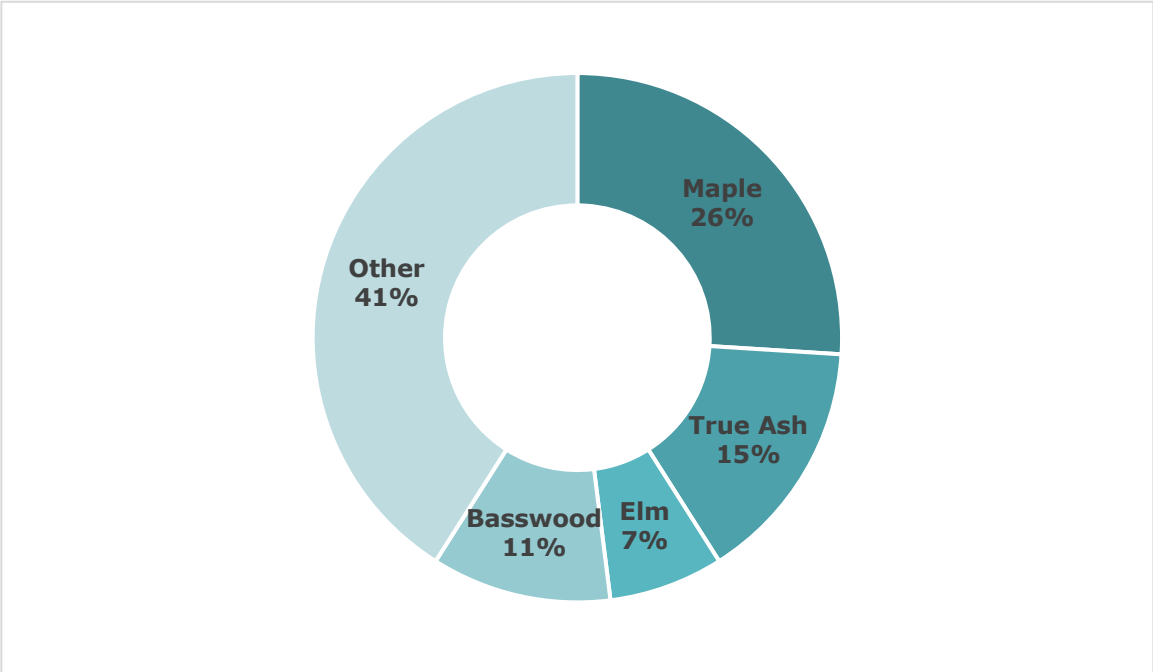
The Central Peninsula had a substantial 1,519 street trees in 2017. Maples were the dominant trees at 26% (Figure 4). A sizable proportion (15%) of the Central Peninsula’s urban forest consists of Green Ash, Black Ash, or Red Ash, which have been known for their tolerance to urban environments. Until now, ash trees had very few diseases or problems with pests. The Emerald Ash Borer is a beetle that arrived in New Brunswick in the Spring of 2018 and trigger a 5-10-year terminal lifespan for these trees once infected. This means that up to 15% of the trees on the Central Peninsula could be at risk of being infected by the beetle.

Figure 4. Percentage composition of the urban tree inventory within the Central Peninsula neighbourhood.

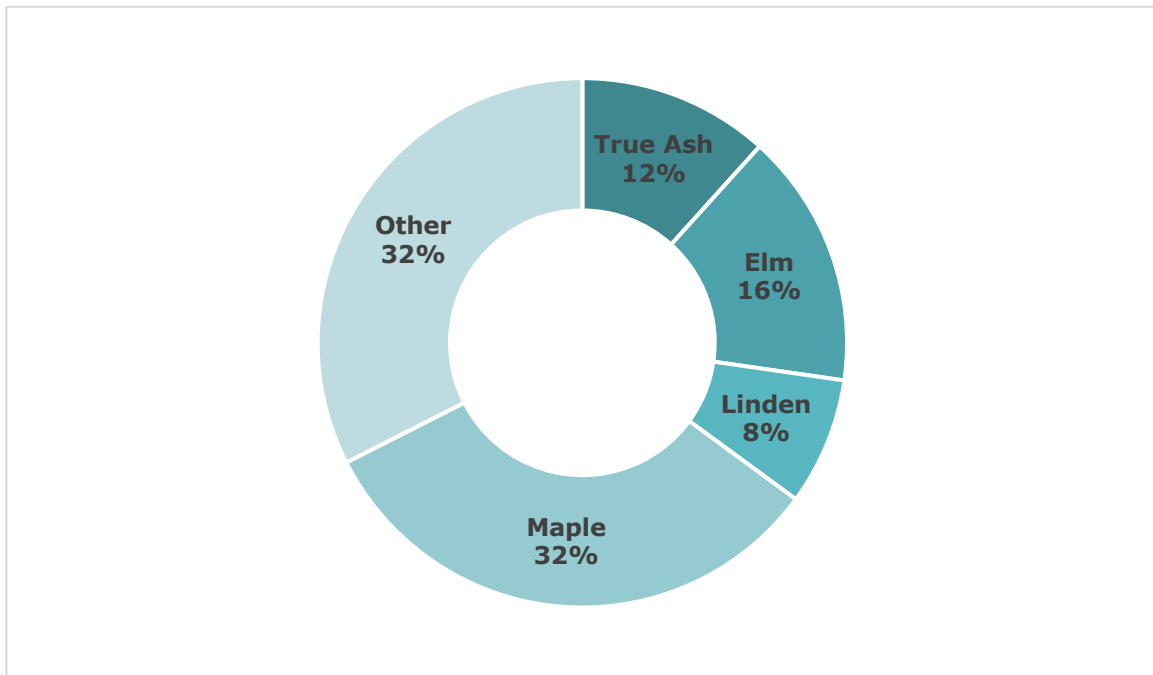
Lower-West species composition can be presented as a percentage composition of each genus in relation to the inventory. Species found at a low percentage (<6%) were grouped as Others. The urban street tree inventory for the Lower-West area counted a total of 587 trees. Like the Central Peninsula, the Lower-West urban tree inventory is dominated by maples (*Acer spp.*), including Sugar Maple (*Acer saccharum*), Silver Maple (*Acer saccharinum*) and the predominant Norway Maple (*Acer platanoides*) (Figure 5). There were also trees from Elms (*Ulmus spp.*) (12%) and Queen Street West had a high volume of true Ash (*Fraxinus spp.*), putting the health status of street trees under threat from the Emerald Ash Borer. Maple

Figure 5. Percentage composition of the urban tree inventory within the Lower-West Saint John area.

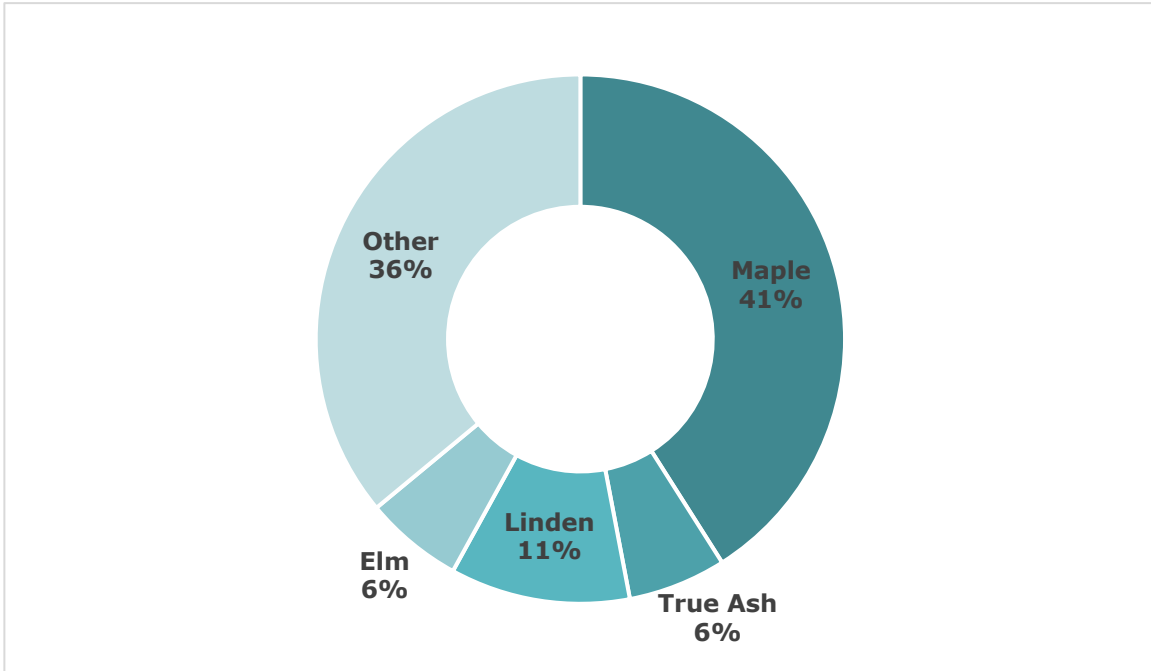
The urban street tree inventory for the North End counted a total of 499 trees. Like the Central Peninsula and Lower-West Side, the North End urban tree inventory is dominated by Maples (*Acer spp.*), including Sugar Maple (*Acer saccharum*), Silver Maple (*Acer saccharinum*) and the predominant Norway Maple (*Acer platanoides*) (36%) (Figure 6). Other species were found including Linden (*Tilia spp.*) (11%), Elm (*Ulmus spp.*) (6%) and true Ash (*Fraxinus spp.*) (6%).

Figure 6. Percentage composition of the urban tree inventory within the North End Neighbourhood.

As with the other inventories, Norway Maple was again found to outnumber the other species found (32%). The Norway Maple is considered invasive in many parts of North America due to its ability to outcompete surrounding foliage with the help of shallow roots. This tree was used as an ornamental street and shade tree for many years and it sees continued use in some municipalities.
