Collaborative Monitoring and Education of Cyanobacteria and Cyanotoxins in the Wolastoq Watershed

ETF Project Number: 220177

2023

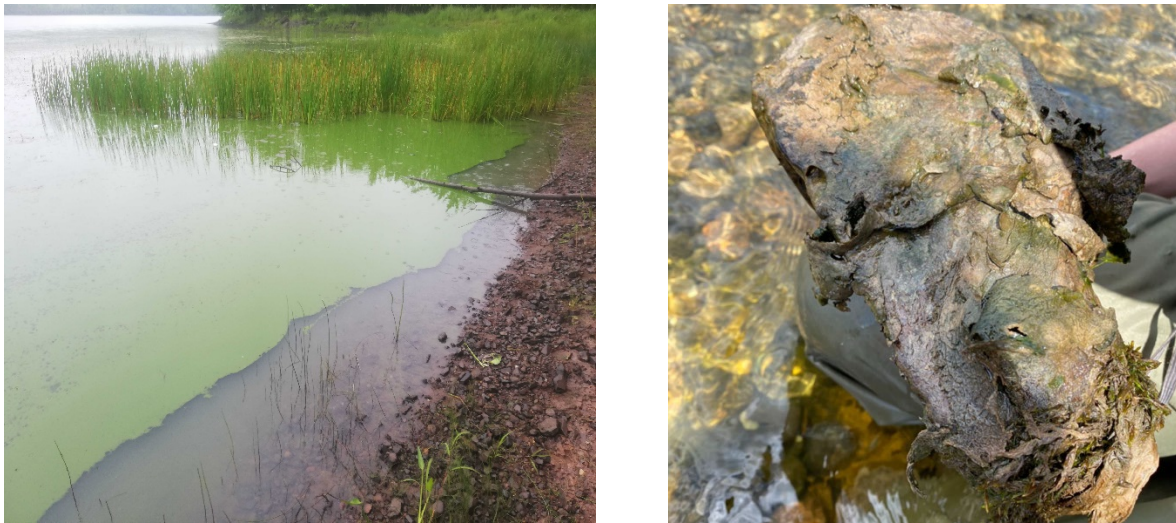
Figure 1: Cyanobacteria can appear in two forms. Left: a surface bloom covering the surface of the water. Right: benthic mat growing on a rock lifted from the bottom of a waterway.
