March 1, 2024

Thinking Water: Community Environmental Monitoring in Greater Saint John

ETF Project Number 220139

Atlantic Coastal Action Program [ACAP] Saint John Inc. 139 Prince Edward Street, Suite 323 Saint John, New Brunswick Canada E2L 3S3 Tel: (506) 652-2227 E-mail: office@acapsj.org Web: www.acapsj.orgReproduction of this report in part or full requires written permission from Atlantic Coastal Action Program [ACAP] Saint John Inc.

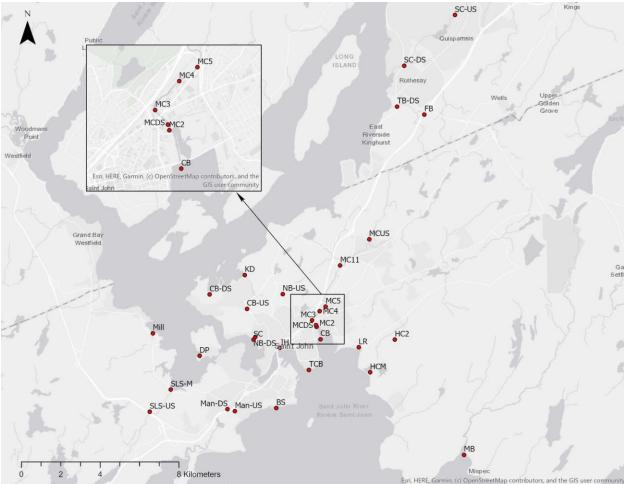
Figure 1. Locations of water quality sampling sites during the 2023 field season. Coordinates and site names are available in Appendix 1.

Water quality monitoring sites are located across 10 different sub-watersheds of the Wolastoq. ACAP Saint John has been monitoring sites within the Marsh Creek watershed for over 30 years. Additional sites were selected to represent a range of brackish and freshwater streams in the Greater Saint John Area. In total, 31 sites were monitored in 2023 (Figure 1). Below is a brief overview of the selected watersheds with the primary threats to water quality identified. Further site descriptions and GPS coordinates can be found in Appendix A.

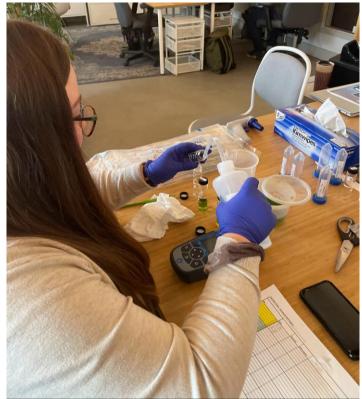
Figure 3. A chemical technology intern from NBCC Saint John conducting laboratory analysis on collected water samples.

Ammonia was measured using the DR900 Nitrogen, Ammonia method (Code 8155) (Figure 3). Ten mL of sample water was added to a clean test tube, and two chemical reagents were added to the sample with time between reagent additions. After allowing the sample to sit for 15 minutes, the colorimeter was calibrated using a blank sample (deionized [DI] water) and the sample was subsequently tested. The ammonia reading provided was in mg/L.

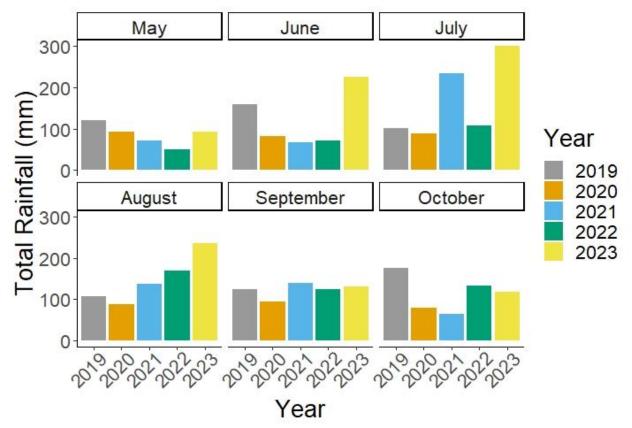
Figure 4. Rainfall per sampling month from 2019 to 2023.

Rainfall data from 2019 to 2023 reveals that the 2023 field season incurred the greatest volume of rain by 27.8% (317.3 mm). Rainfall from May to October of 2023 totaled 1104.3 mm, in comparison to the previous greatest volume of 787 mm in 2019. Similarly, it was found that 57.5% of 2023 sampling dates were affected by rainfall events, a 10% increase of impacted days from 2022 (Table 1).

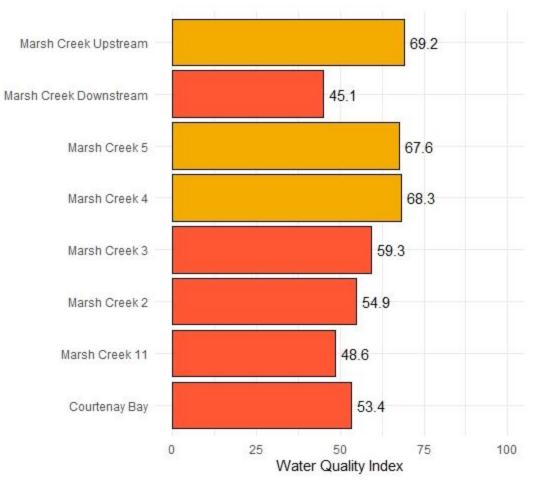
Figure 5. Water quality index (WQI) scores from Marsh Creek sampling locations. WQI scores are calculated from raw water quality data collected in 2023 according to CCME procedures.

In 2023, all sites within the Marsh Creek watershed experienced improved water quality apart from Marsh Creek 11 (Figure 5). Three sites achieved a fair water quality index score while the remaining five sites had marginal water quality. The improvement in stream health can be attributed to overall lower nutrient and bacterial concentrations. The greatest contributor to diminished water quality within Marsh Creek watershed were *E. coli* and phosphate concentrations, both of which generally exceeded guideline limits on most occasions.

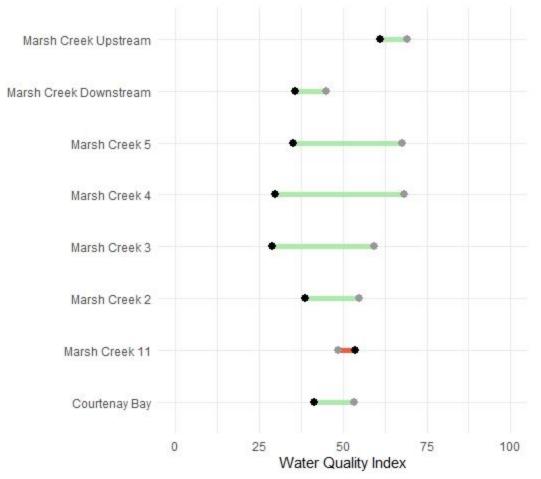
Figure 6. Change in water quality index scores between 2022 (black circles) and 2023 (grey circles) at sites within the Marsh Creek watershed, with colours indicating whether the WQI has improved (green) or declined (red).

All sites experienced significant improvements in water quality between 2022 and 2023, except for Marsh Creek 11, which decreased slightly in 2023 (Figure 6). In contrast, in 2022, five sites had poor water quality, with only two achieving marginal water quality, further demonstrating the marked improvement of 2023. As 2023 incurred more rainfall than 2022, while exhibiting improved water quality despite this, it is suspected that technical errors contributed to the degraded water quality scores seen in 2022. Improvement in water quality can likely be attributed to decreased average concentrations of ammonia, temperature, and increased dissolved oxygen.

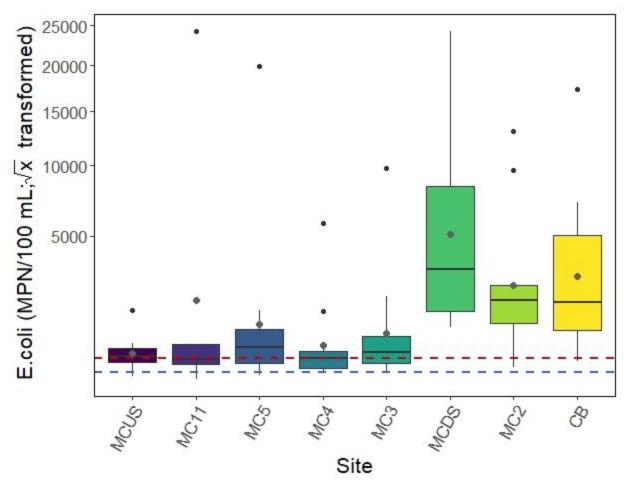
Figure 7. E. coli concentrations (MPN/100 mL) across sites within the Marsh Creek watershed in 2023. The mean values for each site are represented by grey dots, while outliers are represented by black dots. The threshold value (geometric mean concentration of 20200 MPN/100 mL; minimum 5 samples) is represented by the blue dotted line, while the single-sample maximum concentration (400 MPN/100 mL) is represented by the red dotted line.

Each site within the Marsh Creek watershed exceeded the *E. coli* concentration threshold chosen for this report (geometric mean concentration of 200 MPN/100 mL; minimum 5 samples) and a single-sample maximum concentration (400 MPN/100 mL), at least once, if not on most occasions. Historically, Marsh Creek Upstream has had the lowest *E. coli* concentrations and in 2023, concentrations fell below this threshold on 5 of 11 occasions. A limit of a 200 MPN/100 mL average is recommended by Health Canada, where concentrations above this value may pose health risks (Health Canada, 2012). In some cases, *E. coli* concentrations were close to the detection limit (24196 MPN/100 mL); but none exceeded this value in 2023. The sites farthest downstream, Marsh Creek 2 (MC2), Marsh Creek Downstream (MCDS), and Courtenay Bay continued their historical trend of having the highest concentrations of *E. coli*, with Marsh Creek Downstream exhibiting the highest overall average (Figure 7).

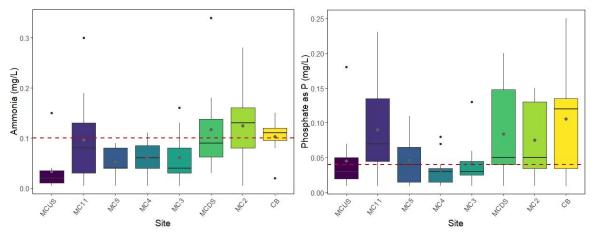
Figure 8. Left- Ammonia concentrations (mg/L) across sites in the Marsh Creek watershed in 2023. The mean values for each site are represented by grey circles, while outliers are represented by black circles, and the threshold limit (0.1 mg/L) is represented by the dotted line. Right- 2023 phosphate concentrations (mg/L) as P across sites in the Marsh Creek watershed. The mean values for each site are represented by grey circles, while the outliers are represented by black circles, and the threshold value (0.04 mg/L) is represented by black circles, and the threshold value (0.04 mg/L) is represented by black circles, and the threshold value (0.04 mg/L) is represented by the dotted line.

In 2023, average ammonia concentrations decreased substantially across all sites, exhibiting less variability overall and lower outlier concentrations. Average concentrations exceeded the threshold of (0.1 mg/L) at three sites (MC2, MCDS, and CB) (Figure 8-Right). Similarly, average phosphorus concentrations decreased at most sites, exhibiting less variability overall and lower outlier concentrations as well. Although most sites (7 of 8, 87.5%) had average PO4 levels above the threshold value (0.04 mg/L), one site (MC4) had an average below. Despite the exceedances, three sites (MC3, MC5, MCUS) had averages close to the threshold (Figure 8- Left). In 2022, both ammonia and phosphate concentrations were elevated considerably compared to previous years; results from 2023 indicate that nutrient levels have returned to normal concentrations for the Marsh Creek watershed and suggesting that technical errors in 2022 had a substantial impact on nutrient data from Marsh Creek. In addition to heavy rainfall events occurring near to and during sampling events, the area surrounding Marsh Creek is highly industrialized, particularly near the downstream locations; the poor riparian cover allows nutrients and other contaminants to readily enter the stream with no filtration or mitigation.

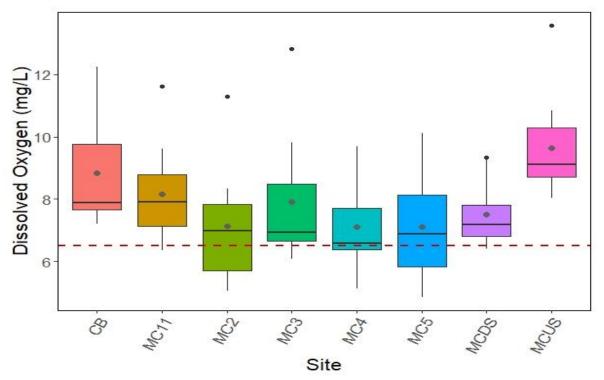
Figure 9. Dissolved oxygen concentrations (mg/L) measured across sites in the Marsh Creek watershed in 2023. The mean values for each site are represented by orange circles, while outliers are represented by blue circles, and the threshold value (6.5 mg/L) is represented by the dotted line.

Average dissolved oxygen (DO) concentrations measured in 2023 were above the threshold value of 6.5 mg/L at all sites within the Marsh Creek watershed (Figure 9). DO values fell below the threshold on fewer occasions in 2023 in comparison to 2022, indicating improved conditions within Marsh Creek. Greater DO levels in 2023 are likely correlated to lower the nutrient input also observed this season.

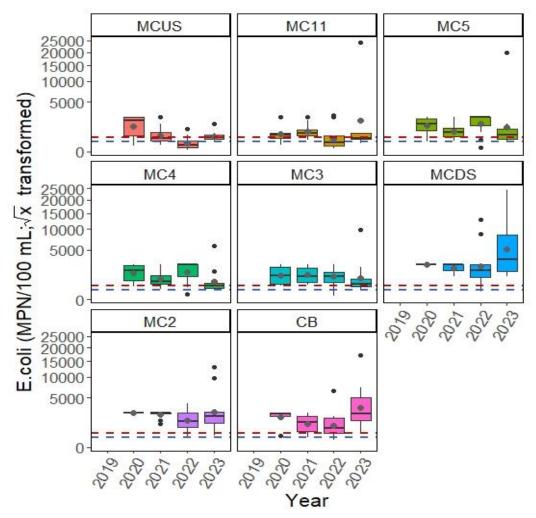
Figure 10. E. coli concentrations (MPN/100 mL) within the Marsh Creek watershed throughout 2020 to 2023 with mean values (grey circles), outliers (black circles), the threshold value (geometric mean concentration of 200 MPN/100 mL; minimum 5 samples) represented by the blue dotted line, while the single-sample maximum concentration (400 MPN/100 mL) is represented by the red dotted line.

2020, fecal coliform concentrations (including but not limited to *E. coli*) were measured rather than *E. coli* concentrations, with that, data from 2019 was not included in Figure 12 below. Fecal coliform counts at Marsh Creek Downstream were historically much higher than those at upstream sites, with extremely high concentrations measured between 2000 and 2015. Following the cessation of raw sewage inputs in 2014, fecal coliform counts declined until more recent years, with the most downstream sites Courtenay Bay, Marsh Creek 2, and Marsh Creek Downstream all presented the highest average *E. coli* values over the last four years. These elevated levels of *E. coli* can likely be attributed to the increased occurrence and volume of rainfall that occurred in 2023. Heavy rain can result in lift station overflows, causing runoff to enter Marsh Creek. Although modernization of combined sewage overflows and lift stations occurred in 2022, the *E. coli* concentrations observed in 2023 indicate that further remediation efforts to reduce sewage outfalls and other sources of pollution within Marsh Creek remain today.

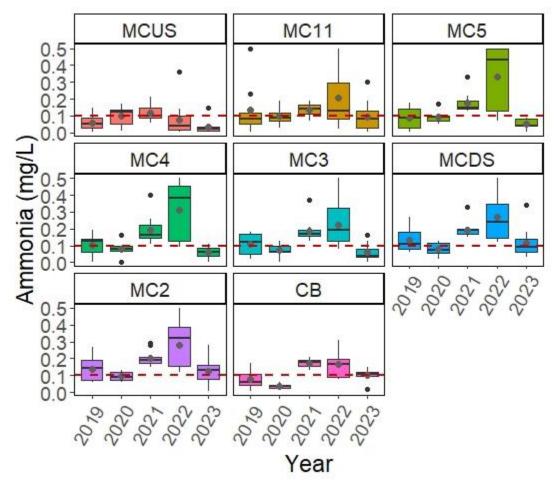
Figure 11. Ammonia concentrations (mg/L) within the Marsh Creek watershed throughout 2019 to 2023. Mean values are represented by grey circles, outliers are represented by black circles, and the threshold value (0.1 mg/L) indicated by the dotted line.

Ammonia concentrations decreased at all sites between 2022 and 2023. Some sites exhibited the lowest average concentrations to date (MCUS [0.03 mg/L], MC3 [0.06 mg/L], and MC5 [0.05 mg/L]), while the remaining sites exhibited concentrations closer to those in 2020 and 2021 (Figure 11). In 2023, the average concentration of most sites remained below or close to the threshold value (0.1 mg/L), with fewer exceedances than 2021 and 2022. Ammonia levels have spiked multiple times over the past three decades, including after the cessation of raw sewage dumping in 2014. The increased ammonia concentrations observed between 2019 to 2022 may indicate continued impact from these pollution sources, presenting the need for further management.

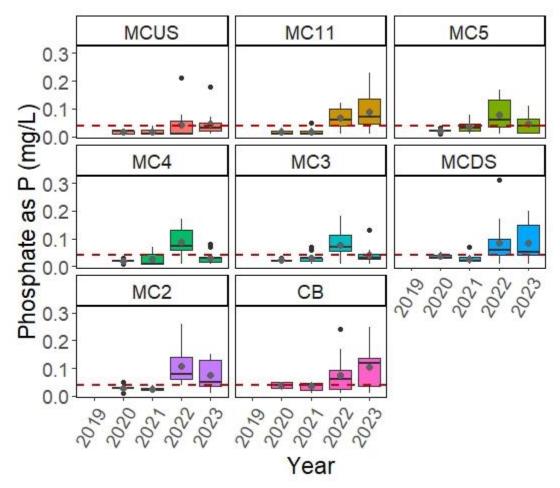
Figure 12. Orthophosphate concentrations as Phosphorus (mg/L) within the Marsh Creek watershed throughout 2019 to 2023. Mean values are represented by grey circles, outliers are represented by black circles, and the threshold value (0.04 mg/L) indicated by the dotted line.

can vary. In addition to traditional sources of phosphorus (stormwater, fertilizers, erosion, etc.), the City of Saint John began adding phosphate to the drinking water supply to reduce corrosion of water pipes. With both lift-station overflows and fire hydrant draining, the phosphorus in the drinking water is likely contributing as a new source of phosphorus in our urban waterways.

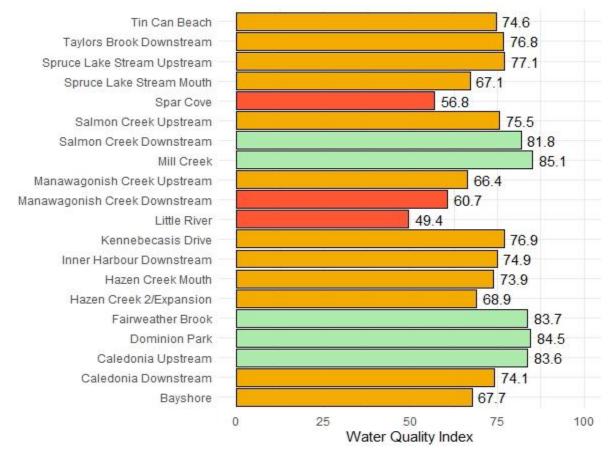
Figure 13. Water quality index values from sites within the Greater Saint John area in 2023.

Like previous years, no sites achieved an excellent water quality index score in 2023 (Figure 13). Of the sites, five exhibited good water quality, while the majority (12 sites) had fair water quality, and the remaining three had marginal water quality; no sites had poor water quality. These scores indicate that all sites had at least one parameter fall outside of the guidelines and threshold values described above. The lowest water quality was observed at Little River (WQI of 49.4) and Spar Cove (WQI of 56.8), while the best water quality was found at Mill Creek (WQI of 85.1) and Dominion Park (WQI of 84.5). The greatest contributing factor to impacted water quality was exceedances of phosphate and *E. coli* concentrations.

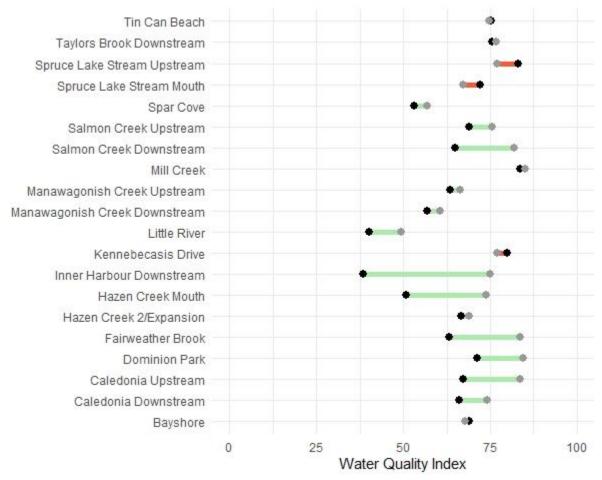
Figure 14. Changes in water quality index scores between 2022 (black circles) and 2023 (grey circles) at sites within the Greater Saint John area, with colours indicating whether the WQI score has improved (green) or declined (red) from 2022 to 2023.

Water quality in 2023 was generally much higher than that of 2022, with improvement in WQI scores observed at 15 sites (comprising 75% of sites) (Figure 14). It is expected that technical errors contributed to the diminished water quality observed in 2022, with results from 2023 aligning more with historical levels. A general decrease in ammonia and *E. coli* concentrations likely contributed to improved water quality conditions within streams of the Saint John and surrounding area.

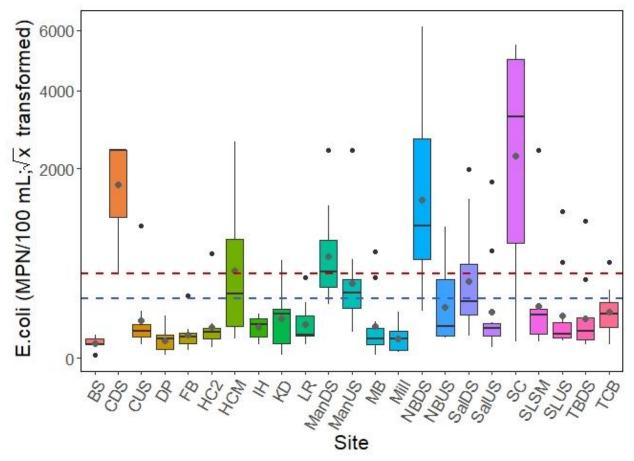
Figure 15. E. coli concentrations (MPN/100 mL) across sites in the Greater Saint John area in 2023. The mean values for each site are represented by grey circles, while the black dots represent outliers. The threshold value (geometric mean concentration of 200 MPN/100 mL; minimum 5 samples) is represented by the blue dotted line, while the single-sample maximum concentration (400 MPN/100 mL) is represented by the red dotted line.

Overall, *E. coli* concentrations in 2023 exhibited less variability, while 47.8% (11 of 23) of sites had mean *E. coli* concentrations above the recommended recreational limit (200 MPN/100 mL) (Figure 15). Like previous years, the highest mean *E. coli* concentrations were measured at Spar Cove (2904 MPN/100 mL), Newman's Brook Downstream (2670 MPN/100 mL) and Caledonia Brook Downstream (1796 MPN/100 mL), continuing their historical trends of highly elevated *E. coli* values. These sites likely experienced considerable sewage inflows or runoff at some points in 2023, resulting in a highly variable

range of *E. coli* concentrations and mean values. Conversely, 52.2% of sites had mean *E. coli* values below the threshold limit, with Dominion Park (25.1 MPN/100 mL) and Mill Creek (28.7 MPN/100 mL) exhibiting the lowest levels. Most sites experienced *E. coli* concentrations above the threshold limit on one or two occasions; these measurements can likely be associated with heavy rainfall events resulting in sewage inputs. Dominion Park's average value of 25.1 MPN/100 mL, with no exceedances of the threshold limit, is excellent as this site is a popular swimming location.

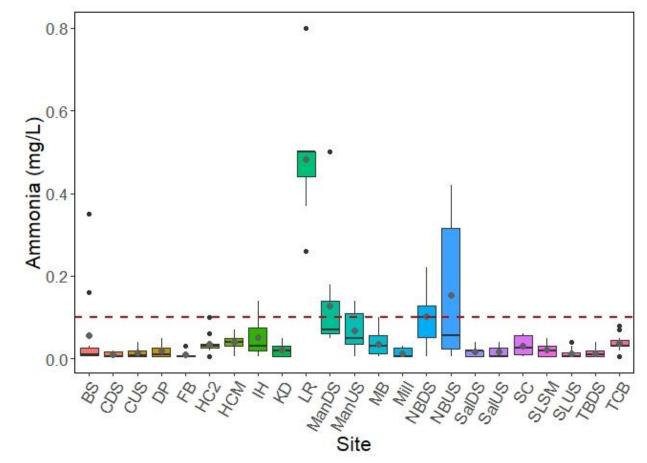
Figure 16. Ammonia concentrations (mg/L) across sites in the Greater Saint John area in 2023. The mean values for each site are represented by grey circles while the outliers are represented by black circles, and the threshold value (0.1 mg/L) is represented by the dotted line.

concentrations. All other sites remained well within the threshold limit, with only two sites exceeding this limit on one or two occasions.

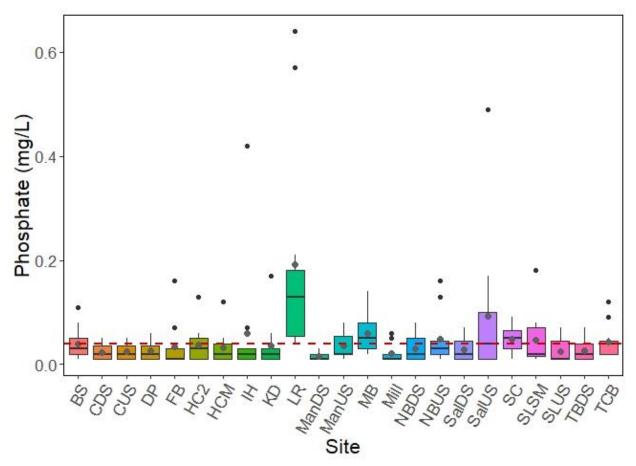
Figure 17. Orthophosphate concentrations (mg/L) as P across sites in the Greater Saint John area in 2023. The mean values for each site are represented by grey circles, while the outliers are represented by black circles, and the chosen threshold value (0.04 mg/L) is represented by the dotted line.

Conversely, Mill Creek (0.03 mg/L) was the only site with an average phosphate concentration below the threshold limit (0.04 mg/L) in 2023 (Figure 17). Three sites were close to the threshold range - Dominion Park and Manawagonish Creek Downstream (0.045 mg/L), and Caledonia Downstream (0.048 mg/L). The highest average phosphate concentrations were measured at Little River (0.288 mg/L), Mispec Beach (0.122 mg/L), and Salmon Creek Upstream (0.115 mg/L). As phosphate is more available in marine coastal waters, higher concentrations are expected at Mispec Beach, while elevated levels at Salmon Creek Upstream are likely due to incurred runoff; as mentioned, Little River is an extremely contaminated stream flowing through an oil refinery.

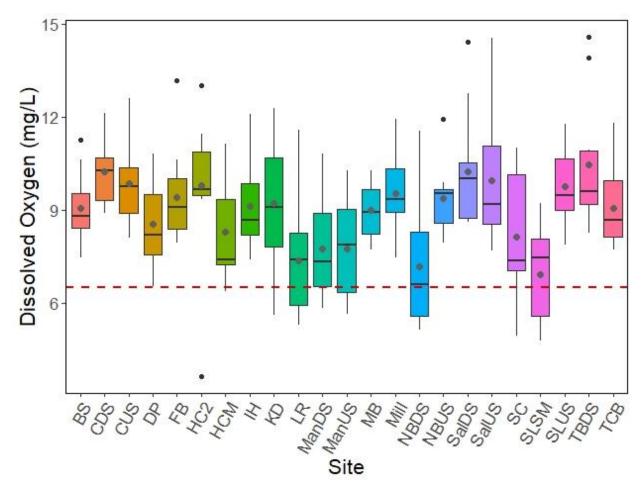
Figure 18. Dissolved oxygen concentrations (mg/L) across sites in the Greater Saint John area in 2023. The mean values for each site are represented by orange circles, while the outliers are represented by blue circles, and the threshold value (6.5 mg/L) is represented by the dotted line.

In 2023, average dissolved oxygen concentrations were above the threshold limit (6.5 mg/L) across all sites within the Saint John and surrounding area. Like last year, DO measurements fell below the threshold on limited occasions at a few sites. Like previous years, Newman's Brook Downstream (NBDS) continued to exhibit some of the lowest concentrations (7.18 mg/L), apart from Spruce Lake Stream Mouth (SLSM), which had the lowest DO levels in 2023 (6.92 mg/L). These low DO measurements are expected at SLSM given its highly vegetated, low-flow conditions, like those of NBDS, in addition to high nutrient concentrations and fecal contamination. Overall, most sites in the Greater Saint John area have appropriate oxygen levels to support aquatic life (Figure 18).

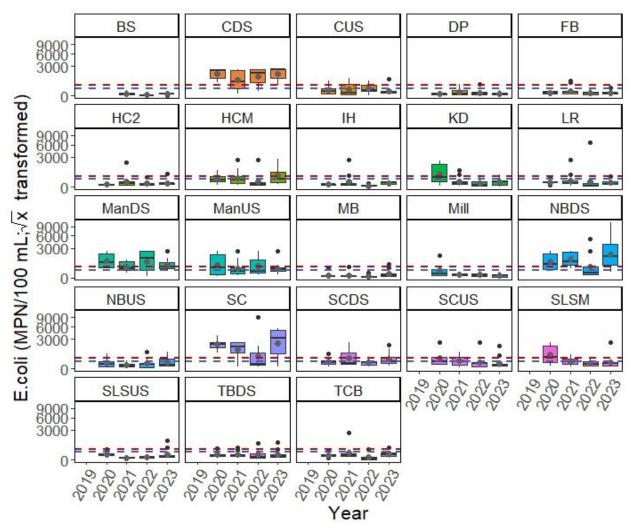
Figure 19. E. coli concentrations (MPN/100 mL) across sites in the Greater Saint John area between 2019 and 2023. The mean values for each site are represented by grey circles, outliers are represented in black circles, the threshold value (geometric mean concentration of 200 MPN/100 mL; minimum 5 samples) is represented by the blue dotted line, while the single-sample maximum concentration (400 MPN/100 mL) is represented by the red dotted line.

E. coli concentrations increased at 60.9% (14 of 23) of sites within the Saint John and surrounding area between 2022 and 2023 (Figure 19). As 2023 experienced the largest volume and frequency of rainfall within the five-year timeframe, single measurements of high *E. coli* concentrations may be the result of this. Increased runoff providing elevated nutrient concentrations, in combination with higher temperatures, allow for increased bacterial growth; these sites should be monitored closely in the following years to further investigate *E. coli* concentrations.

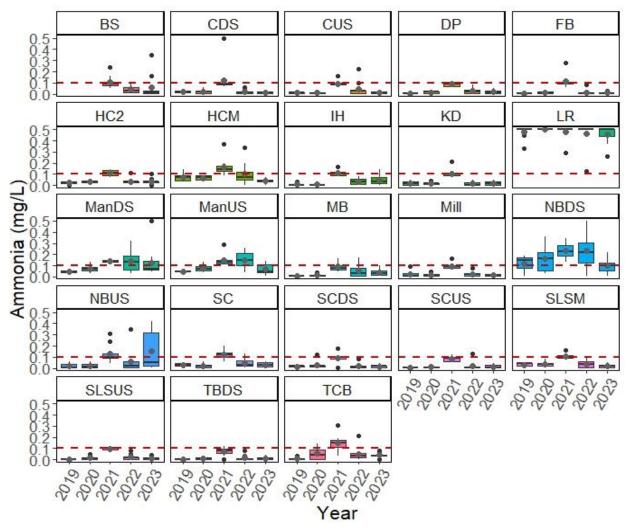
Figure 20. Ammonia concentrations (mg/L) across sites in the Greater Saint John area between 2019 and 2023. The mean values for each site are represented by grey circles, the outliers are represented by black circles, and the chosen threshold value (0.1 mg/L) is represented by the dotted line.

Overall ammonia concentrations were found to be lower in 2023, decreasing at 78.3% of sites (18 of 23) when compared with 2022 (Figure 20). In general, ammonia levels were less variable in 2023, although five sites did exhibit an increased mean concentration (BS, HC2, IH, KD, and NBUS), despite this, only three sites had mean concentrations above the threshold limit (0.1 mg/L). Like previous years, most sites continued to have average concentrations below the threshold. In contrast, average phosphate concentrations increased at 60.9% of sites (14 of 23) between 2022 and 2023, with all but one site (Mill Creek [0.032 mg/L]) exhibiting average concentrations above the threshold limit (0.04 mg/L) (Figure 21). Little River has consistently had the highest average values of both ammonia and phosphate over the years, with ammonia frequently exceeding the detection limit (0.5 mg/L) of lab equipment, and both phosphate and ammonia exceeding threshold limit guidelines.

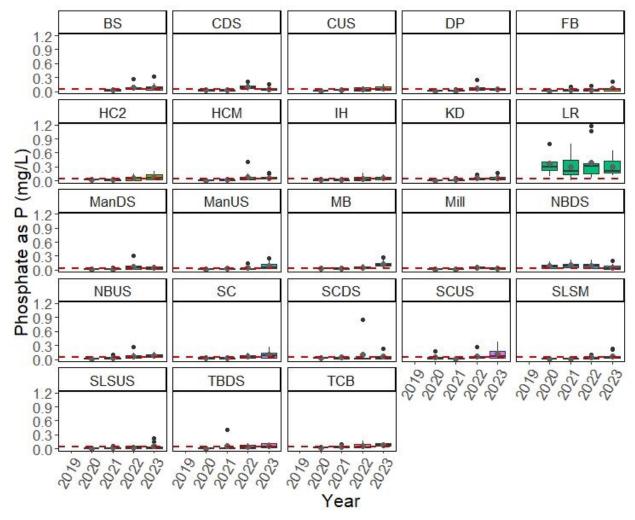
Figure 21. Phosphate concentrations as Phosphorus (mg/L) across sites in the Greater Saint John area between 2019 and 2023. The mean values for each site are represented by grey circles, the outliers are represented by black circles, and the chosen threshold value (0.04 mg/L) is represented by the dotted line.

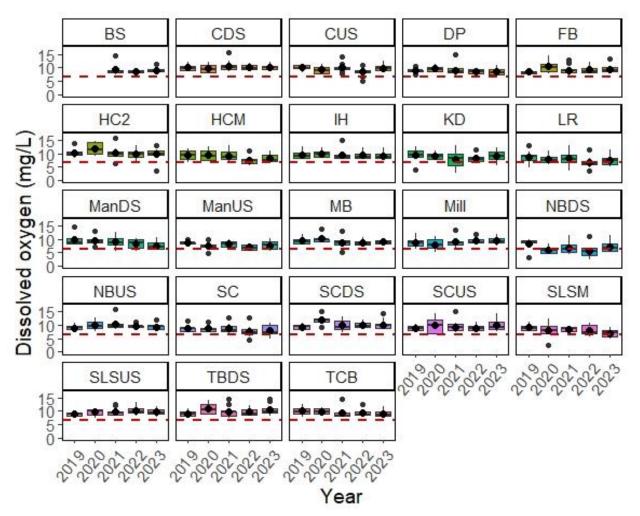
Figure 22. Dissolved oxygen (mg/L) across sites in the Greater Saint John area between 2019 and 2023, with mean concentrations represented by orange circles, outliers represented by blue circles, and the chosen threshold value (6.5 mg/L) represented by the dotted line.

Average dissolved oxygen concentrations have generally remained stable at sites within the Saint John and surrounding area between 2019 and 2023. All twenty-three locations had average DO concentrations above the threshold limit (6.5 mg/L) in 2023 (Figure 22) with concentrations increasing at 60.9% of sites (14 of 23). In 2023, temperature decreased at 78.3% of sites (18 of 23) (Figure 23). Like DO, temperature values have remained stable over the years as well, with all sites maintaining an average temperature well below the threshold value (23.5 $^{\circ}$ C), this suggests that streams within the greater Saint John area can provide thermal refuge for sensitive aquatic species.

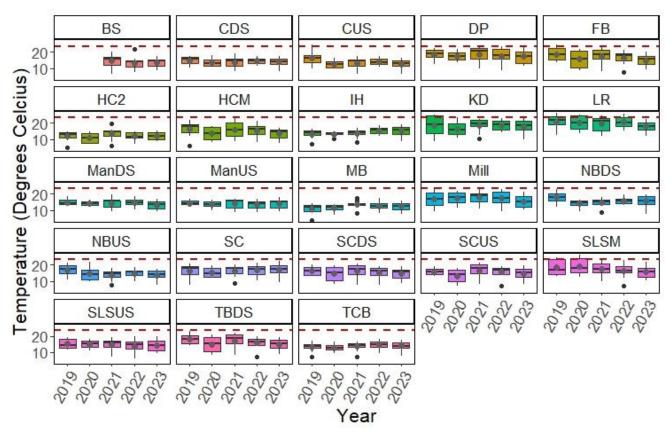
Figure 23. Water temperature ($^{\circ}C$) across sites in the Greater Saint John area between 2019 and 2023. The mean values for each site are represented by grey circles, with outliers represented by black circles, and the threshold value (23.5 $^{\circ}C$) is depicted by the dotted line.

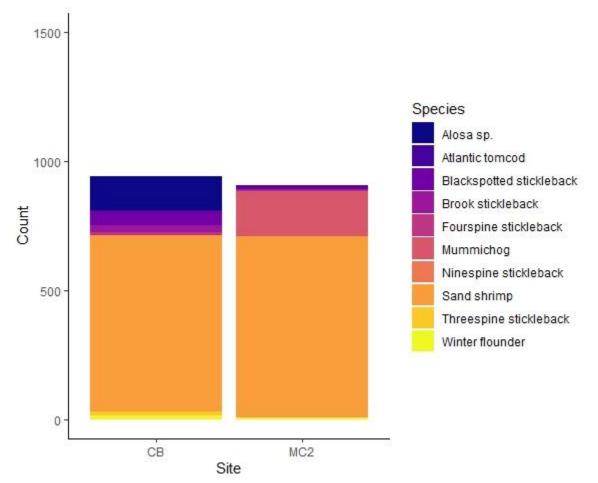
Figure 25. Total number of individuals collected using seine nets in the Harbour Monitoring program between July and October of 2023.

In total, 1848 individuals across 10 species were captured in seine nets in 2023 between the two harbour fishing sites (Figure 25). As observed in 2022, the most abundant species caught was sand shrimp (*Crangon septemspinosa*; 74.9% of total catch), followed by Mummichog (*Fundulus heteroclitus*; 9.6% of total catch) and *Alosa sp.* (7.1% of total catch). More individuals were caught in seine nets at Courtenay Bay and Marsh Creek 2 in 2023 in comparison to 2022. Sand shrimp remained the top species in accordance with historical trends; however, the Atlantic silverside was replaced by the Mummichog as the

second most-caught species in 2023. The change in abundance of Atlantic silverside is likely due to the delayed sampling period which began in July rather than May, missing the migration of Atlantic silverside, while the increased observation of Mummichog could be associated with sampling during their breeding season.

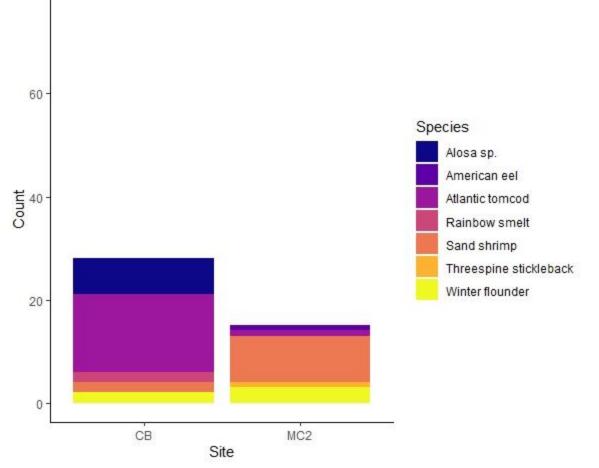
Figure 26. Total number of individuals collected using fyke nets in the Harbour Monitoring program between July and October of 2023.

In 2023, a total of 43 individuals representing 7 species were captured in fyke nets (Figure 26). Like previous years, Atlantic tomcod *(Microgadus tomcod)* represented the largest proportion of the species caught (37.2% of the total catch), followed by sand shrimp (23.9% of the total catch). More individuals were caught at Courtenay Bay (65.1% of total catch) than at Marsh Creek 2 (34.8% of total catch). Most tomcods were caught at Courtenay Bay, with only one captured at Marsh Creek 2; in contrast, most sand shrimp were caught at Marsh Creek 2.

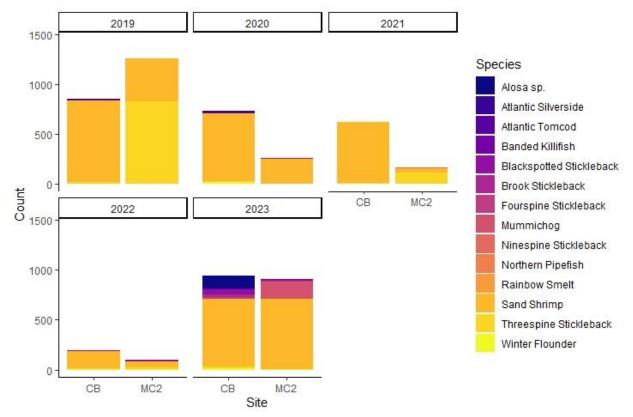
Figure 27. Total catch by seine net between July to October across years at Courtenay Bay and Marsh Creek 2.

abundance and richness captured in seine nets increased at both sites in 2023, with 2023 representing the second largest abundance observed since 2019 (Figure 27). Similarly, more species were caught in fyke nets at Courtenay Bay, while abundance at Marsh Creek 2 remained alike in 2023 in comparison to 2021 and 2022 (Figure 28). As mentioned, changes in abundance in species such as Atlantic silverside is likely due to the delayed sampling period, while increased observations of other species like Mummichog may be associated with the breeding season. Additionally, changes to water quality may better support species like Alosa sp., Mummichog, and Blueback Herring, which were observed in greater numbers at both sites in 2023, compared to previous years.

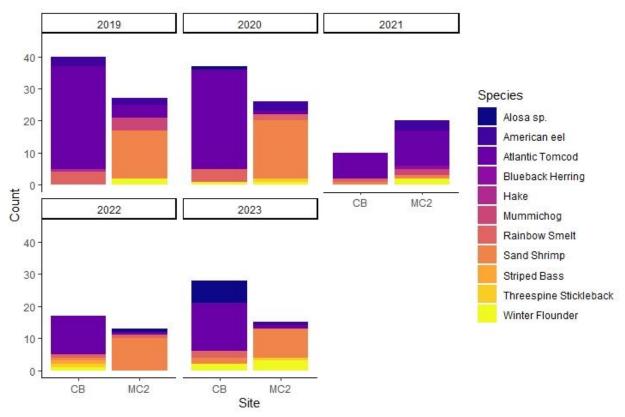
Figure 28. Total catch by fyke net between July to October across years at Courtenay Bay and Marsh Creek 2.
