Living Coastal: Exploring Coastline Changes in Saint John, New Brunswick

ACAP Saint John 2022

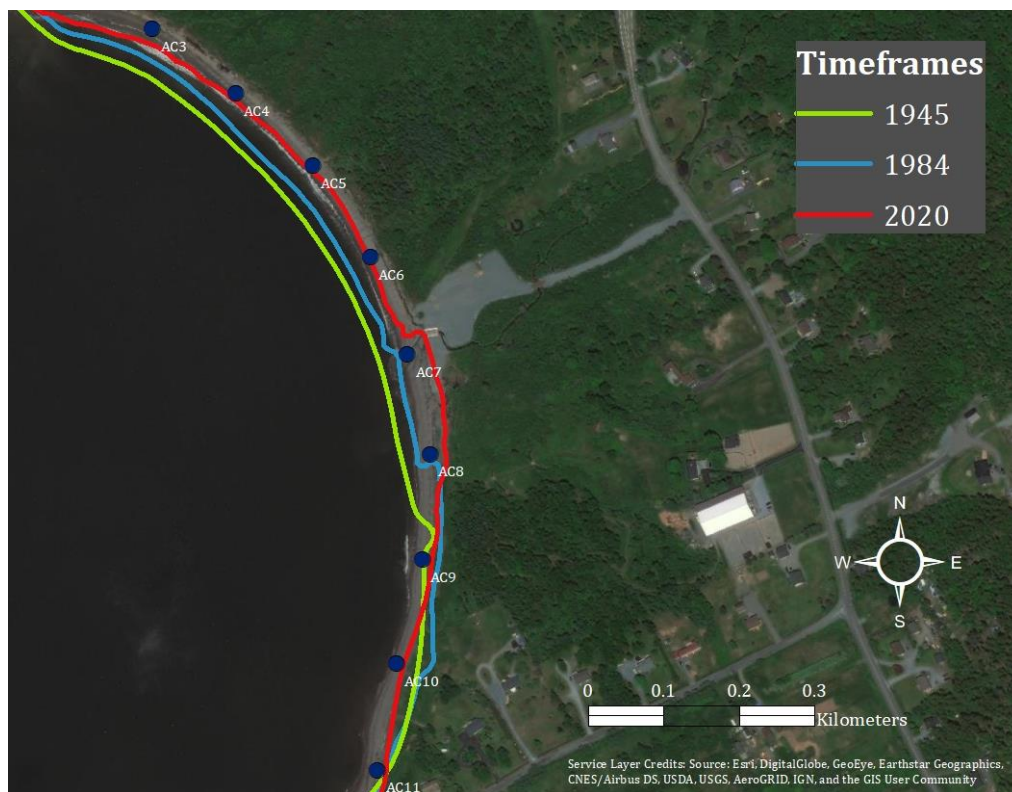
The historical trend at Anthony's Cove is predominantly erosion with the largest change appearing at the outlet of Bean Brook between AC7 and AC8 (Figure 5). The NSM in this area is the highest at this site, at -48.76 meters. Recently, a culvert has been installed in this area, altering the watercourses along the coastline. These changes may correspond with the high degree of erosion as well as the accretion of material that is shown at AC9-AC11 at the former mouth of Bean Brook. The erosion highlighted along AC3-AC6, provides the second highest NSM values for Anthony's Cove averaging -30.25 meters of net shoreline movement. Where riprap is installed along Anthony's Cove Road, the average of NSM is calculated at -3.3 meters with an EPR of -0.05 meters per year suggesting that riprap is effectively slowing the rate of erosion but not preventing it completely.

Figure 5: Coastline changes at Anthony's Cove showing areas of erosion through most of the site and accretion at AC9-AC11 (Himmelstross et al, 2018b). The points represent the sections of the Living Coastal site assessments.

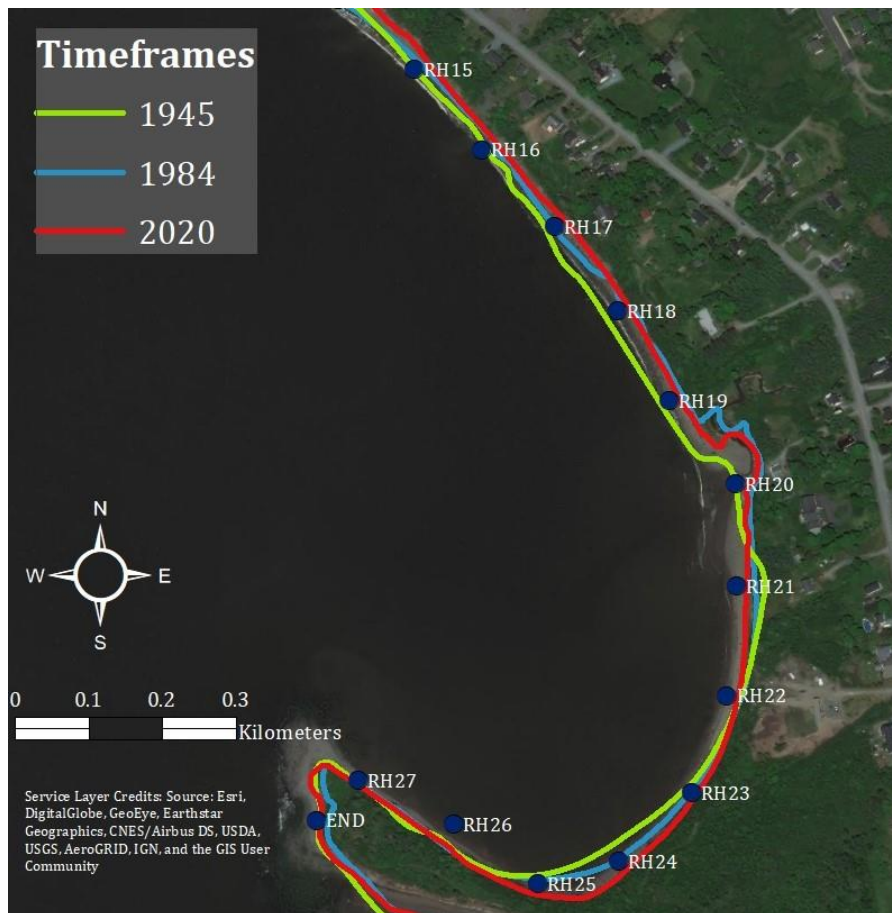
At Red Head, the shoreline changes are apparent along the coast, particularly between the 1945 and 2020 shorelines (Figure 6). While Table 6 presents the average of NSM at Red Head to be -11.35 meters, there are several areas that have a higher degree of shoreline change including the outlet of

Beyea Brook at RH20 which shows -36.27 meters of net shoreline movement. Beyond RH21 the coastline appears stable (where the timeframes appear to overlap) however further into the cove, a higher degree of erosion is observed around RH24 and RH25. At the tip of Cranberry Point (RH27-END) it appears that very little shoreline movement has occurred throughout the timeframes analyzed.

Figure 6: Coastline changes at Red Head (Himmelstross et al, 2018b). The points represent the sections of the Living Coastal site assessments.

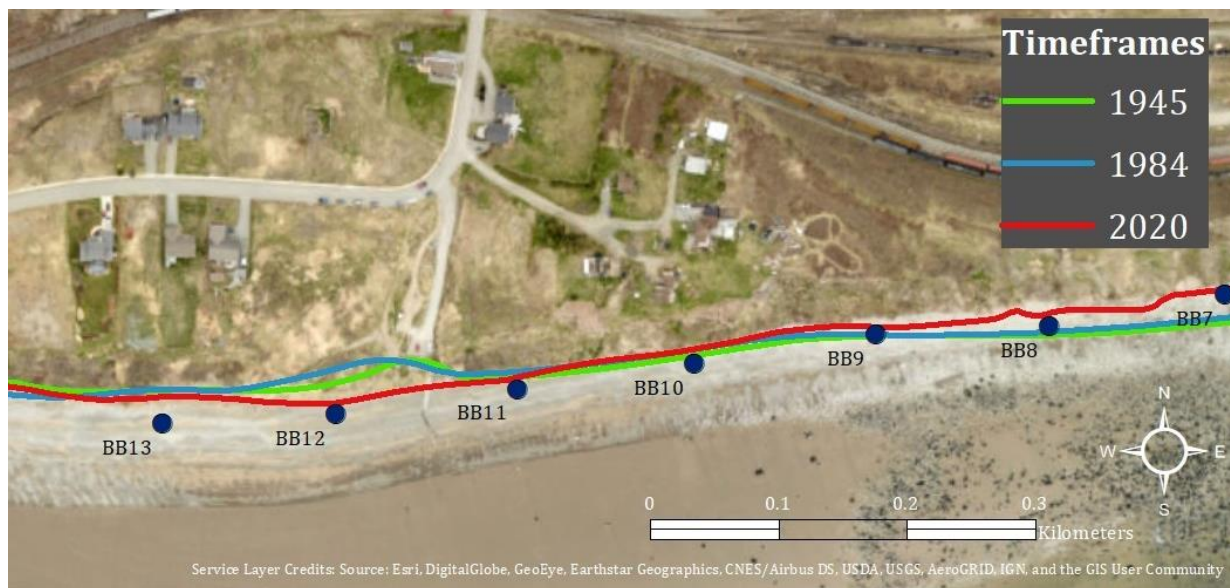
The historical analysis of Bayshore Beach shows some stability along the coastline where the timeframes appear to overlap (Figure 7). At BB7 and BB8, a higher degree of erosion is confirmed as the 2020 shoreline has retreated from the 1945 and 1984 shorelines. At the parking lot, the historical trend shows erosion between 1945 and 1984, and then material accumulation is observed at the 2020

timeframe. This accretion of material could be from development in the area including paving of the roadway and installation of the culvert in BB11.

Figure 7: Coastline changes at Bayshore Beach showing areas of erosion and accretion (Himmelstross et al, 2018b). The points represent the sections of the Living Coastal site assessments.

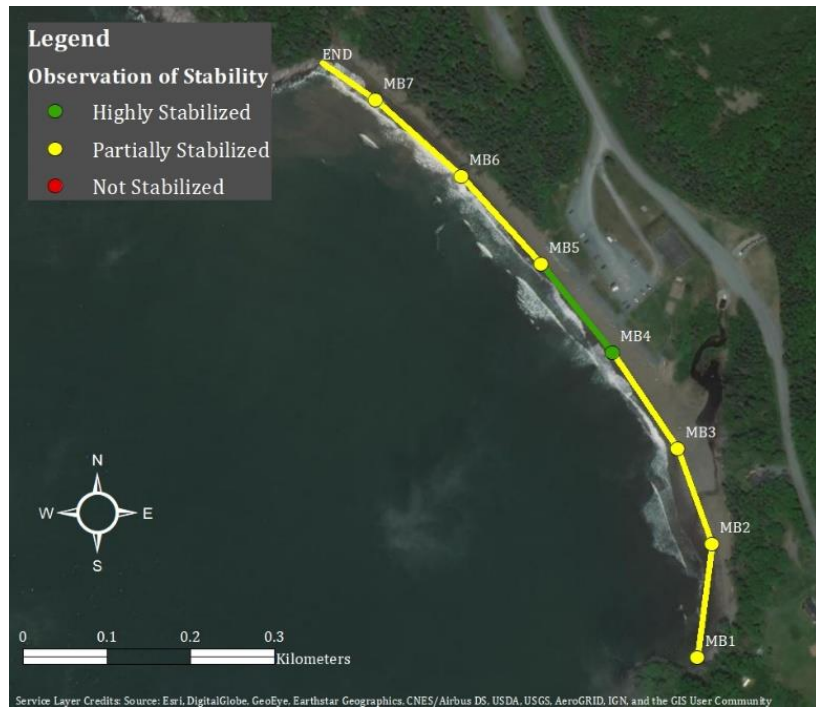
Figure 10: Observation of stability at Mispéc Beach observed summer 2021.

- Overall, the site is partially stabilized except in one section where riprap is in place allowing the shoreline to be highly stabilized (Figure 10).

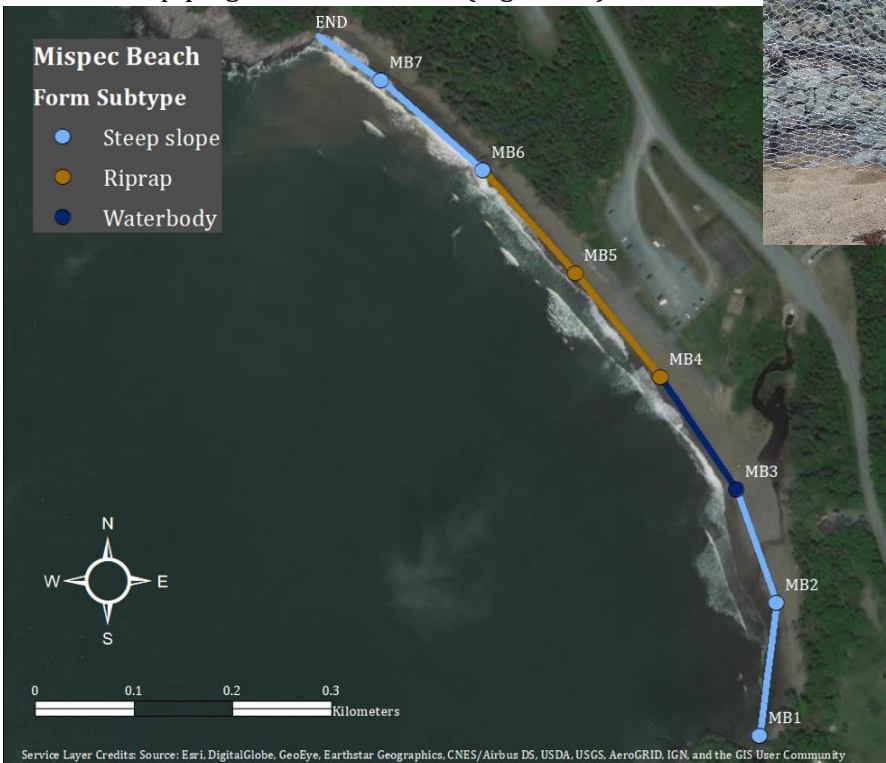
Table 8: Mispec Beach site assessment data summary.

Assessment Variable	Observation	Notes
Predominant Observation of Stability	Partially stabilized	Only one section is highly stabilized (MB4). This is where protection is in place and will require maintenance and repairs.
Land Use	Recreational	Residential area starting in MB1 and transitioning quickly to recreational.
Vegetation	Fully or mostly vegetated	Trees and grasses are the dominant vegetation.
Soil Textures	Clay and clay with sand layer overtop	Typical for this area. Some loamy sand observed.
Primary Form Type	Steep slope	Predominantly steep slopes with anthropogenic installation of riprap to stabilize slope in MB4 and MB5. Waterbody at MB3 where unnamed brook outlets onto the beach.
Slope Range and Average	40-100% slope range with an average of 71%	Greatest slope is where riprap is installed in MB4 and at the easternmost point MB1. Slope at beach access in MB3 is approximately 58%.
Backshore	Predominantly fines with gravel as secondary material type	Cobble and some bedrock found in sections MB1/MB2 and at END.

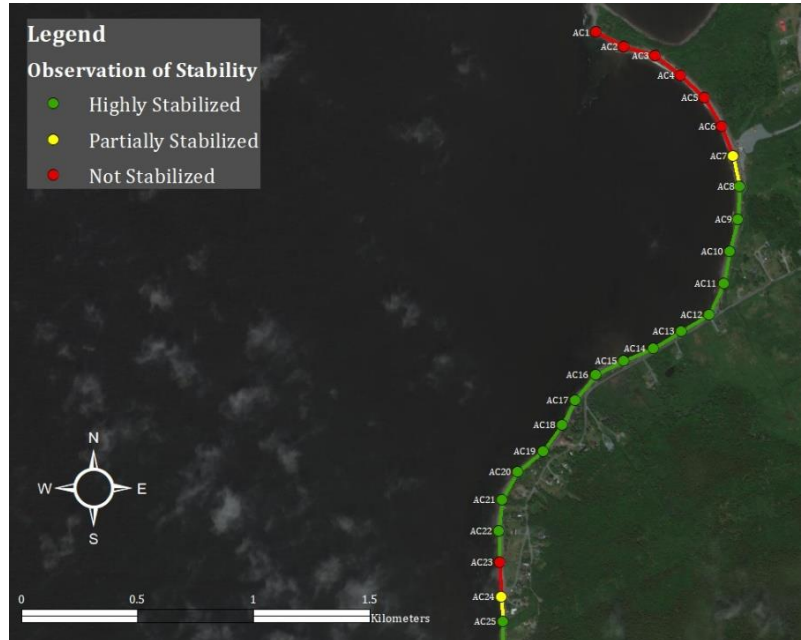
- Appears highly stabilized, however residents are highly vulnerable to extreme weather, storm surge, and sea level rise (Figure 13).
- Stability is gained by presence of riprap, vegetation, and rock material in the foreshore.
- In AC23, privately installed riprap stretches approximately 40 m, however as a whole, this section is not stabilized.
- Coastline is a mix of forms with a large section of riprap along Anthony's Cove Road (AC12-AC18) (Figure 14).

Figure 13: Stability of Anthony's Cove observed in summer 2021. A large section of the coastline is highly stabilized but highly vulnerable to the impacts of extreme weather, storm surge, and sea level rise.

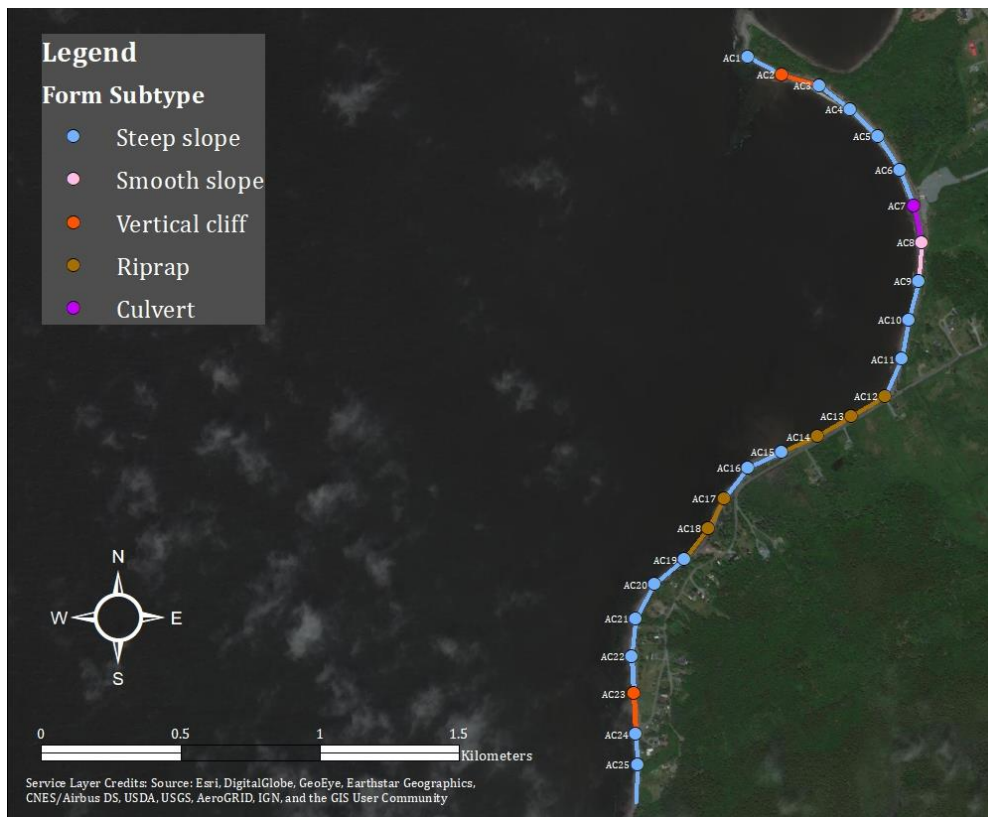
Figure 14: Form types along Anthony's Cove observed in summer 2021.

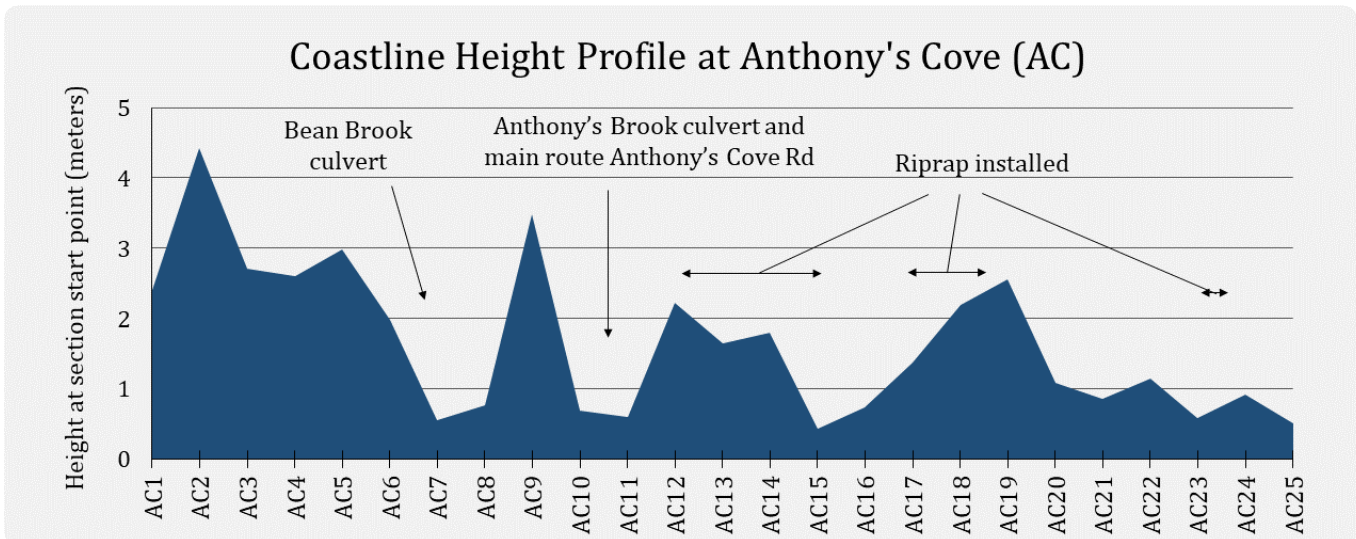
Figure 16: Height profile for Anthony's Cove observed in summer 2021 highlighting changes in form type and locations of infrastructure. AC9 and AC19 were both observed as steep slopes with full vegetation. Runoff was observed in several sections as a large contributor to erosion. At AC15 and AC16 riprap is disrupted and a parking lot lookout is observed.

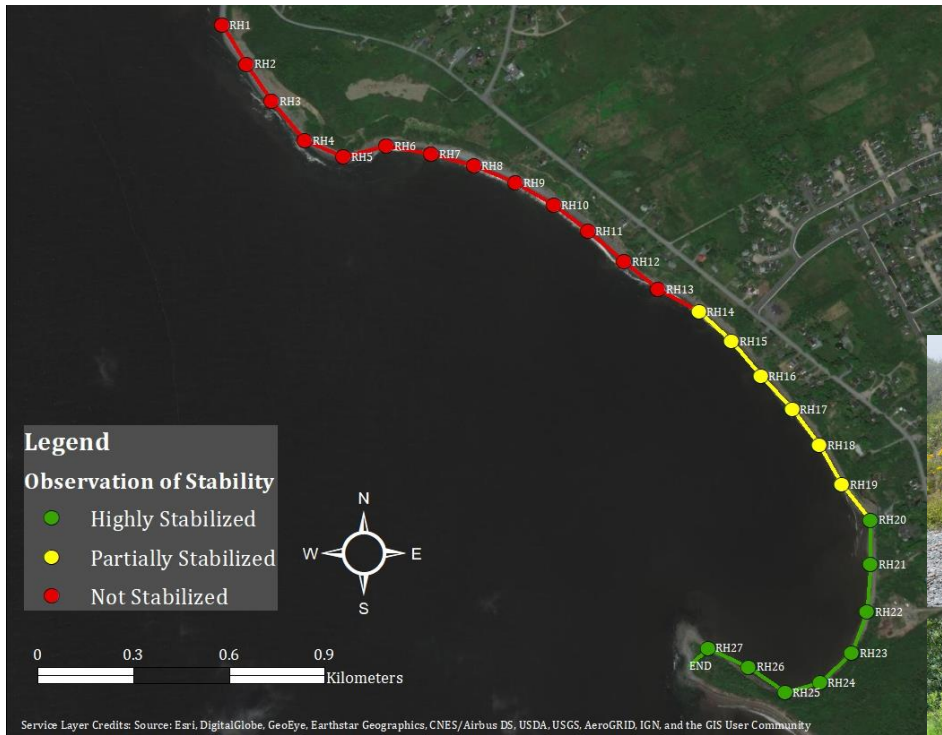
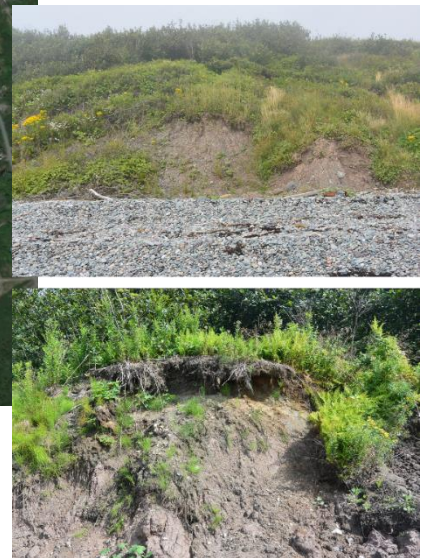
- The largest section of Red Head is not stabilized, and previous slumping events are observed. Areas with partial stability may be due to protective installations put in place (Figure 18).

- The coastline is highly stabilized at RH20-END due to the geography where the cove is sheltered from erosional elements and the presence of vegetation (Figure 18).

Figure 18: Stability of Red Head observed in summer 2021. Images: Top left, majority of the coastline are steep slopes that are not stabilized. Bottom left, overhanging vegetation is observed.

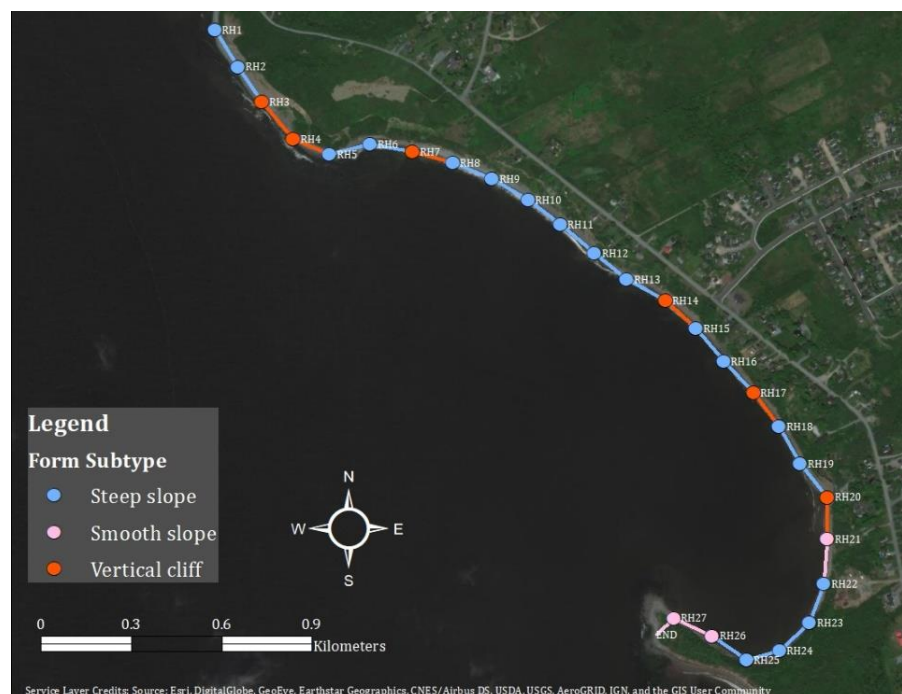
Figure 19: Form types observed at Red Head in summer 2021.

- Steep slopes are the predominant form type (Figure 19).
- Debris and damaged protection efforts are observed (Figure 20).
- Homes are observed close to the edge of the slope and many areas where debris has fallen into the backshore (Figure 20A/C).

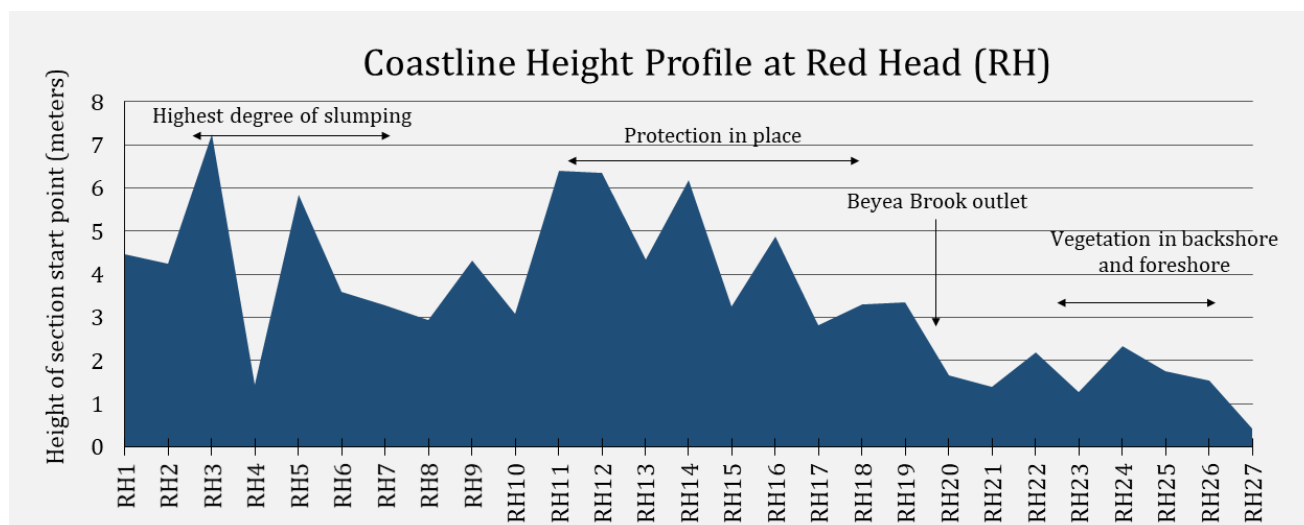
- Erosion is observed beyond installed protection suggesting that high water events have surpassed protective measures.
- Coastline is high from RH1-RH16 and then slowly declines toward Beyea Brook (Figure 21).

Figure 21: Height profile for Red Head observed in summer 2021 highlighting changes in form type and key infrastructure. Slumping is observed throughout the coastline. Debris littering the backshore in RH9 and RH11.

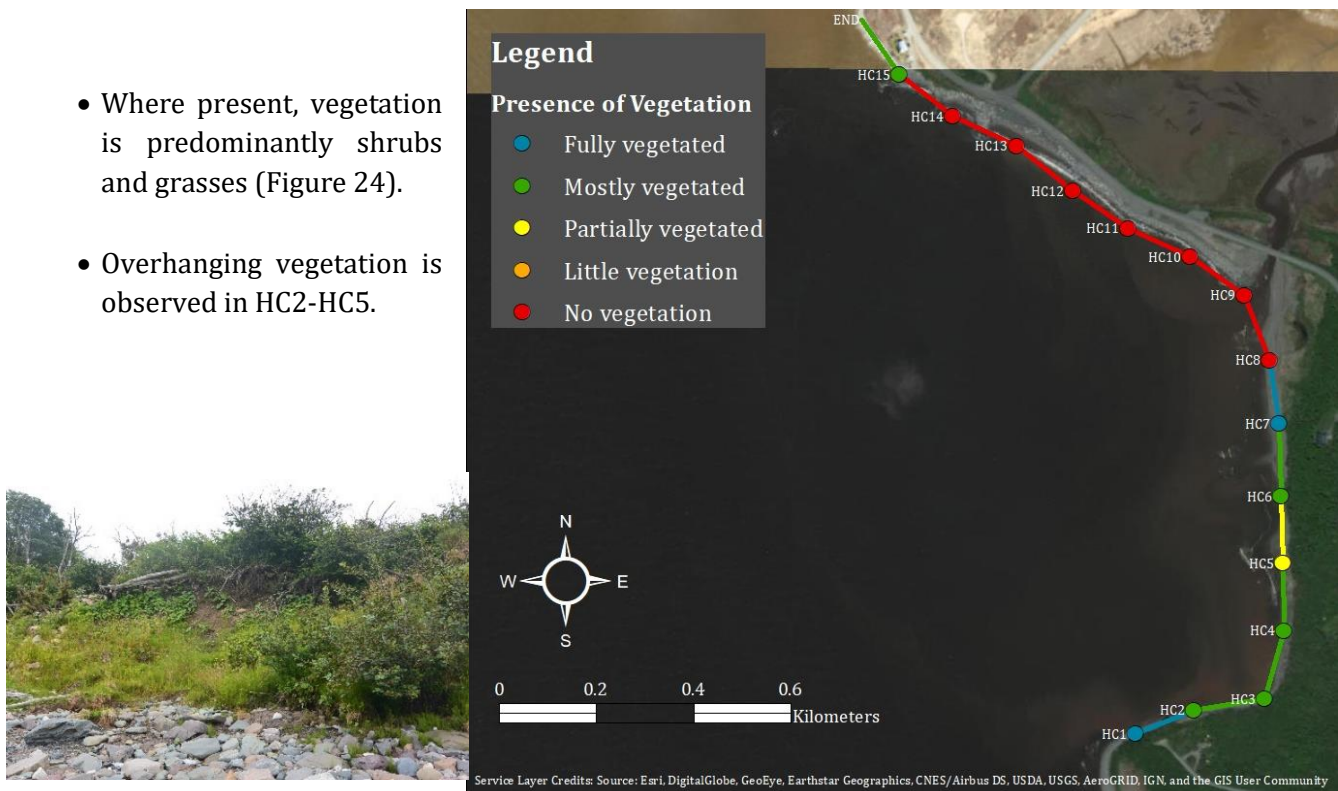
- Where present, vegetation is predominantly shrubs and grasses (Figure 24).
- Overhanging vegetation is observed in HC2-HC5.

Figure 24: Vegetation observed summer 2021 at Hazen Creek. Image left, showing shrubs and grasses with some overhanging vegetation on the slope in HC4.

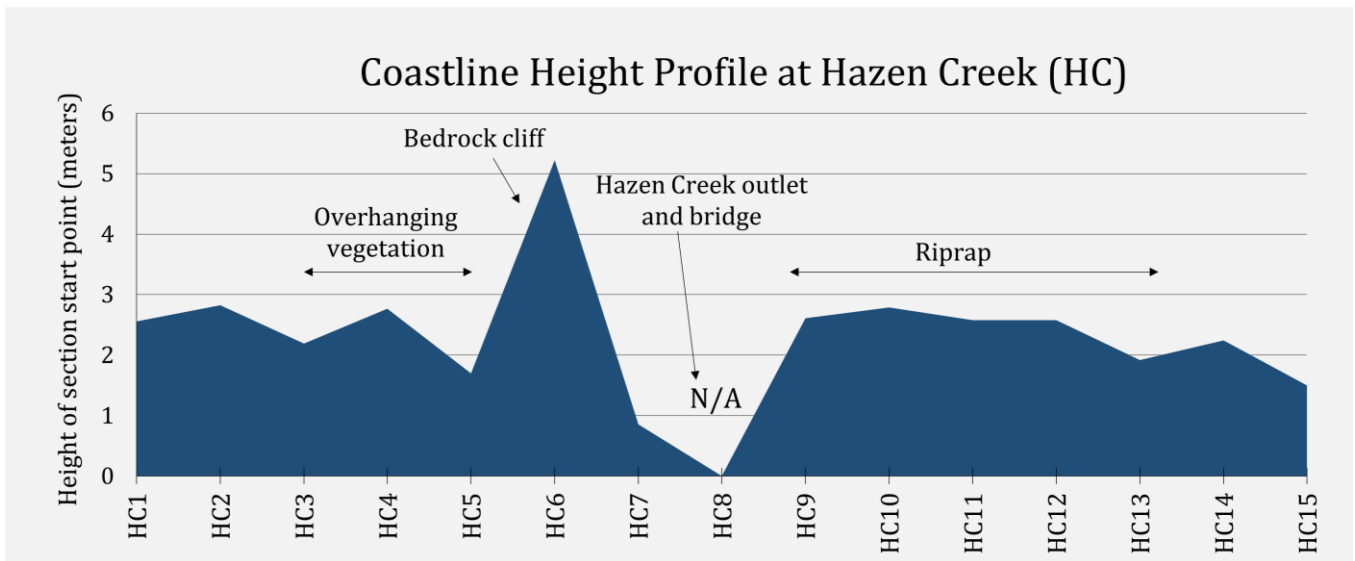
Figure 26: Height profile for Hazen Creek observed in summer 2021 highlighting changes in form type and key infrastructure. Homes in HC1-HC3 and HC15. Culvert outlet at HC13.

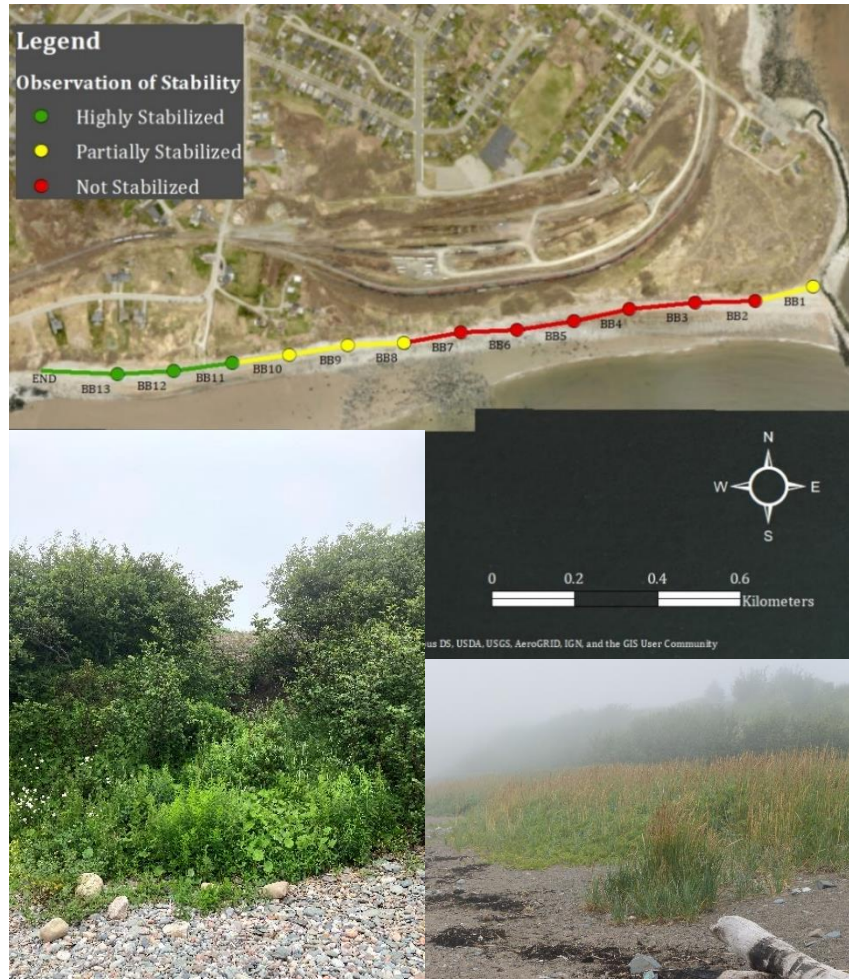
- Sections BB11-END are observed to be highly stabilized, but residents and infrastructure are highly vulnerable to storm surge and sea level rise (Figure 28).

Figure 28: Observation of stability at Bayshore Beach in summer 2021. Images: left, vegetated slopes observed from BB12-END creating natural protection for residential infrastructure. Right, vegetation around public beach access in BB11 before slope increases where residential development is observed.

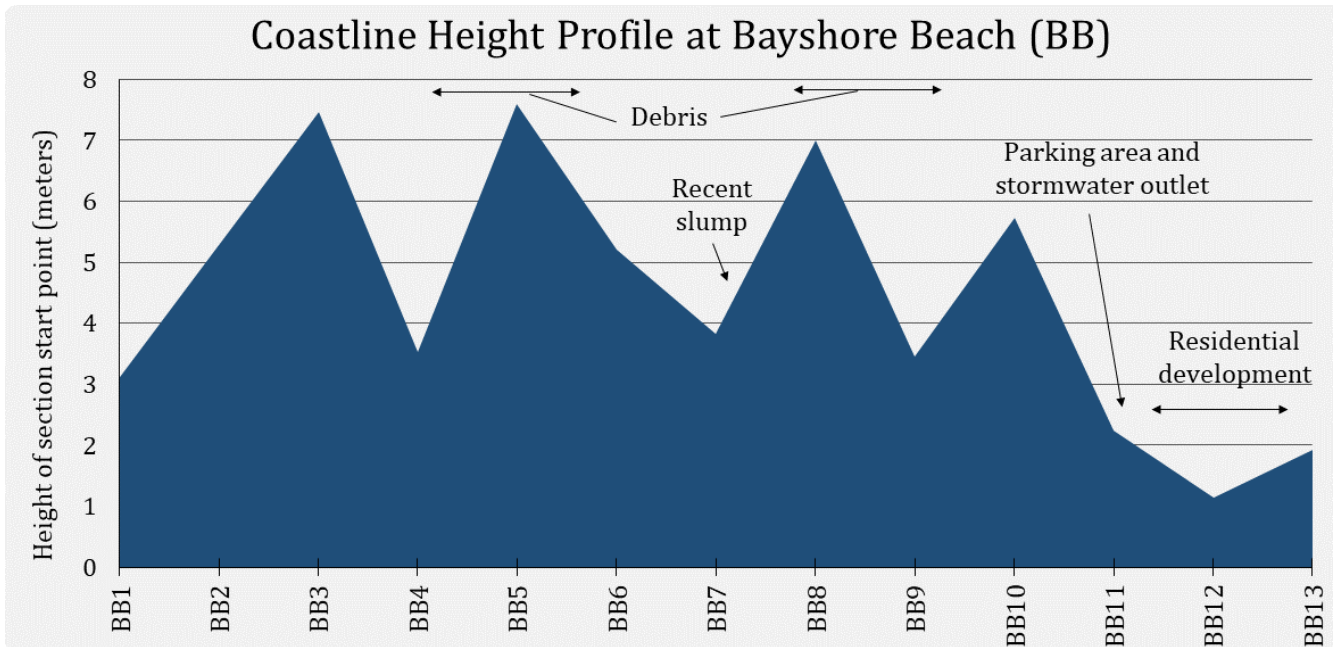
- Majority of the coastline is vegetated including steep slopes and slumped areas creating a high degree of variation in the height profile (Figure 30).

Figure 30: Height profile observed at Bayshore Beach in summer 2021 highlighting form changes and key infrastructure. Successional slumping is observed throughout the coastline.

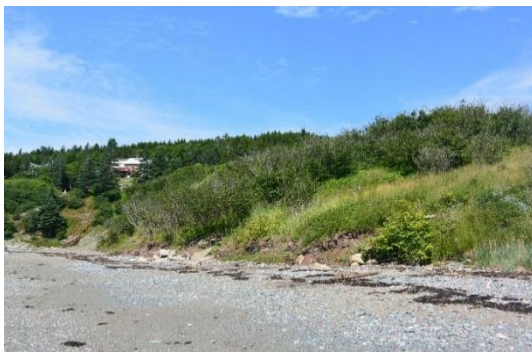
- No active erosion was observed until DC4-END where coast is not stabilized (Figure 32).
- Where stability is reduced, sand is the observed soil texture (Figure 32).
- Piping outlets observed in DC3 and runoff drainage and erosion in DC4.
- Fully to mostly vegetated with prominent vegetation type being shrubs (Figure 33).

Figure 32: Observation of stability at Duck Cove summer 2021. Image left: Eroded section at DC4 where coastline is not stabilized and sand is the predominant soil texture. Staircase access is on the left where vegetation returns but erosion is observed around the access point.

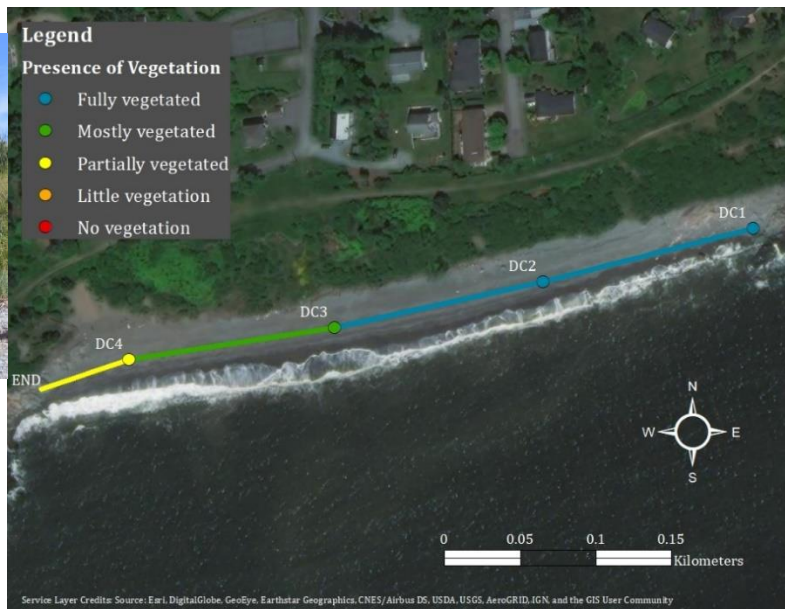
Figure 33: Presence of vegetation observed at Duck Cove in summer 2021. Image top, predominantly shrubs and grasses observed throughout the coastline. Note the home in the distance of DC3.

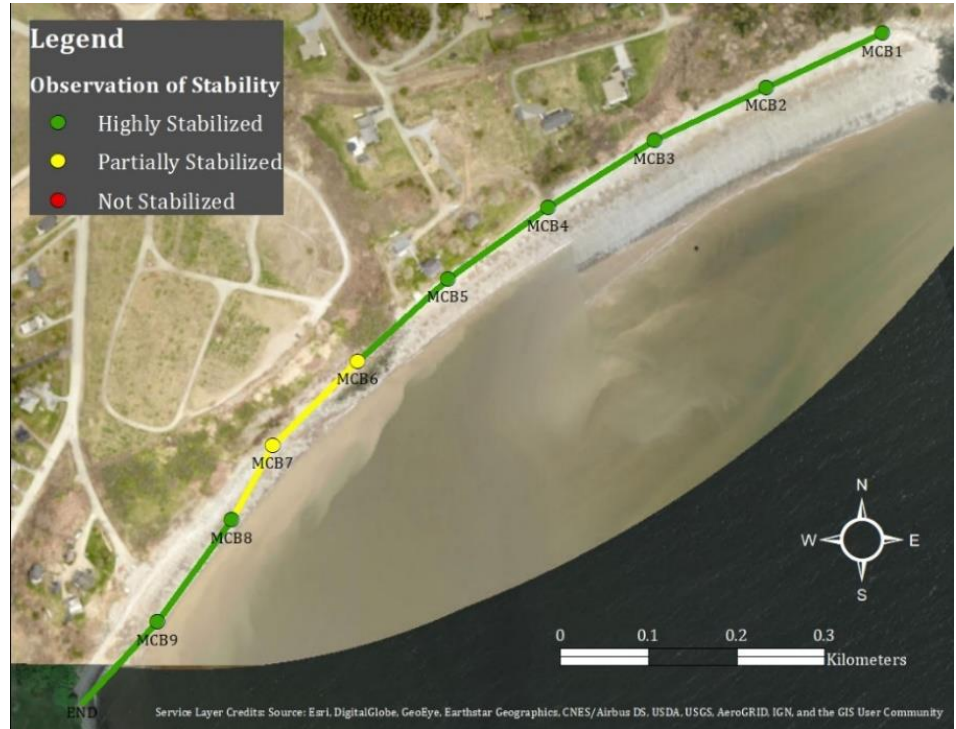
- Majority of the coastline is stabilized but highly vulnerable to sea level rise and storm surge (Figure 35).
- Impacts from erosion in the parking area in MCB8 where structural and asphalt debris are observed.

Figure 35: Observation of stability at McLaren's Beach in summer 2021.

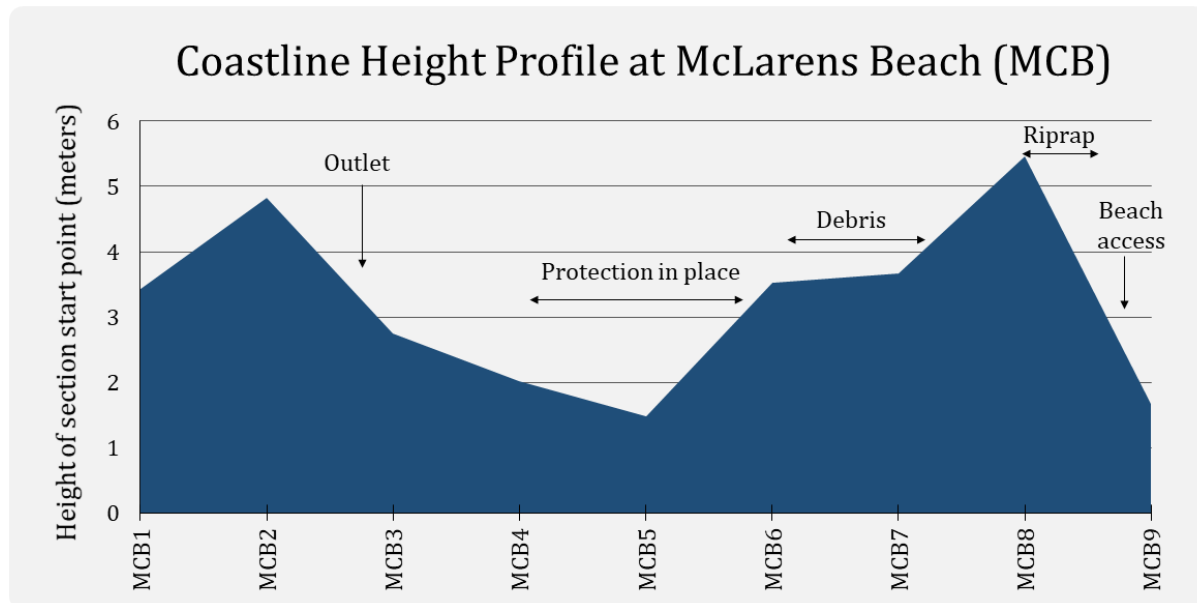
- Form heights are lowest where the seawalls are in place and at the beach access (Figure 38).

Figure 38: Height profile at McLarens Beach observed summer 2021 highlighting key infrastructure.

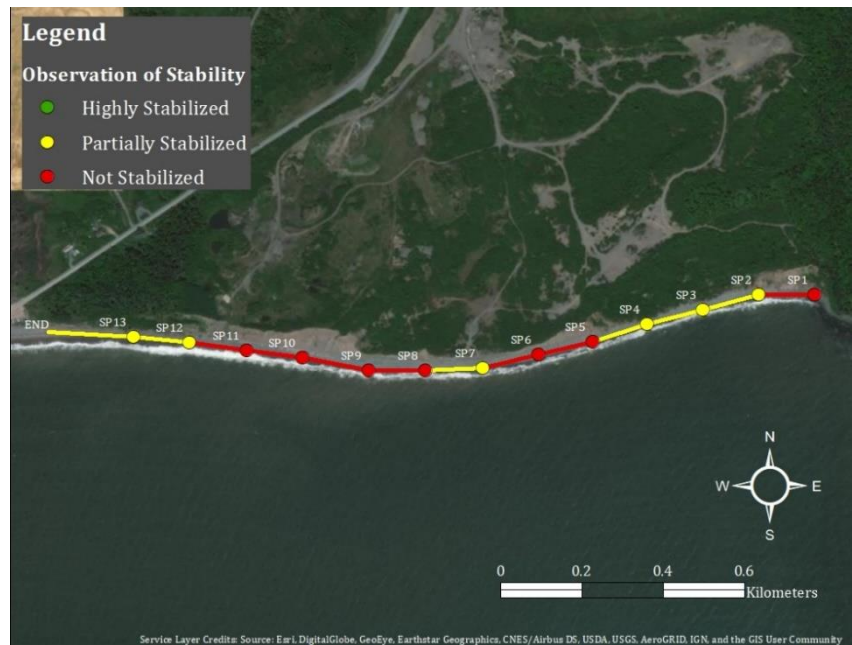
- No area is highly stabilized (Figure 39).
- Signs of active and historical erosion observed including falling rocks and trees, large erosional channels from urban runoff, and slumped material (Figure 40).
- Vegetation is observed on previously slumped material revegetated the coastline.

Figure 39: Observatiobn of stability at Sheldon Point in summer 2021.

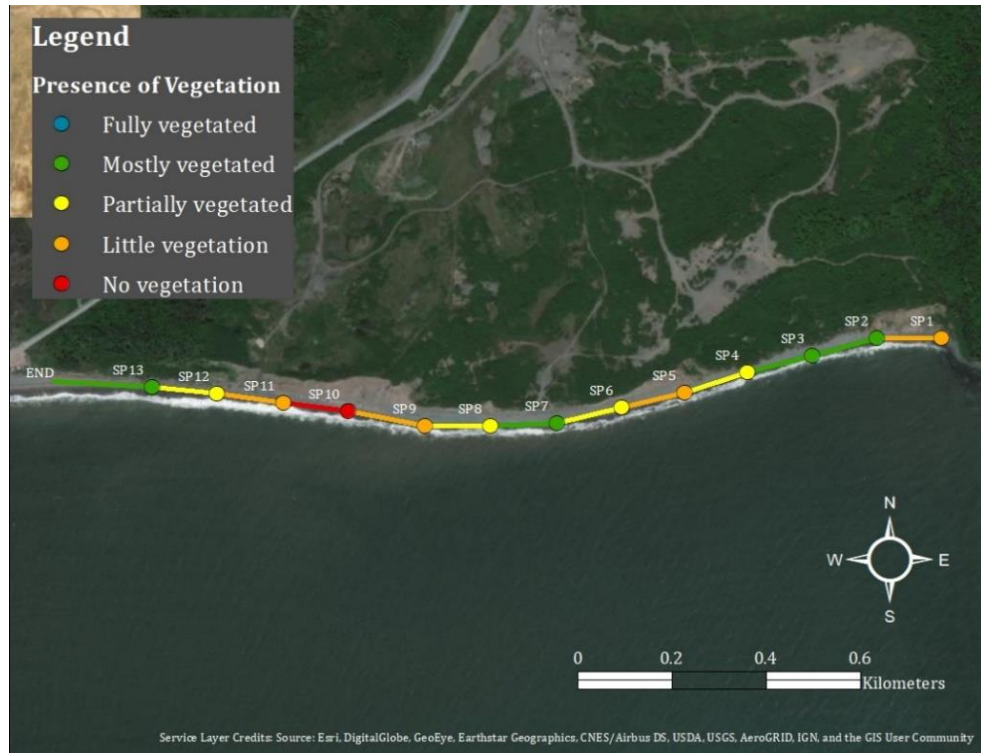
- None of the sections are fully vegetated (Figure 41).
- Predominant vegetation type varies between grasses and shrubs.
- Steep slopes and cliffs are the predominant form types observed (Figure 42).

Figure 41: Presence of vegetation observed at Sheldon Point in summer 2021.

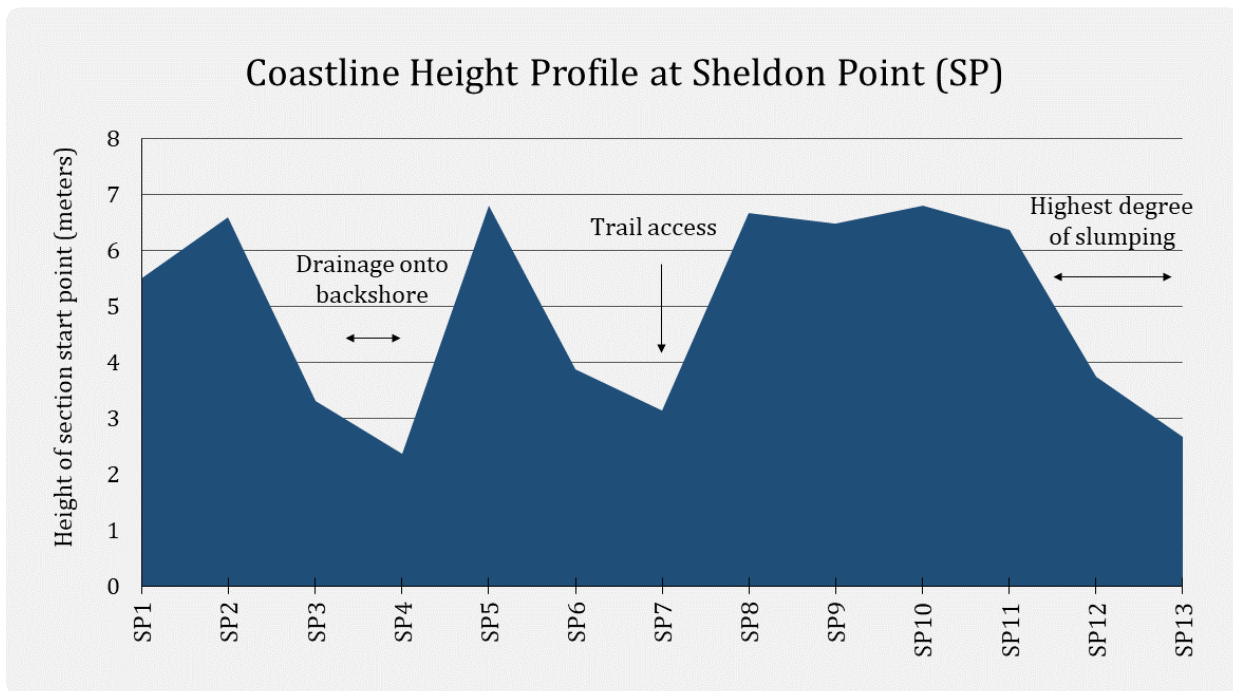
- Clay loam and sandy loam on top of clay are observed throughout the site (Figure 43). This soil texture is highly vulnerable to erosion from runoff and wave action.
- High variation in slope heights is observed with lowest points at SP7 where trail access is observed, and at SP12-END where the parking lot is located (Figure 44).

Figure 44: Height profile for Sheldon Point observed in 2021 highlighting for changes and key features. Slumping is observed throughout the entire coastline. Little to no infrastructure was observed with the exception of debris in SP7 and SP11, and a pipe outlet on the slope of SP11.

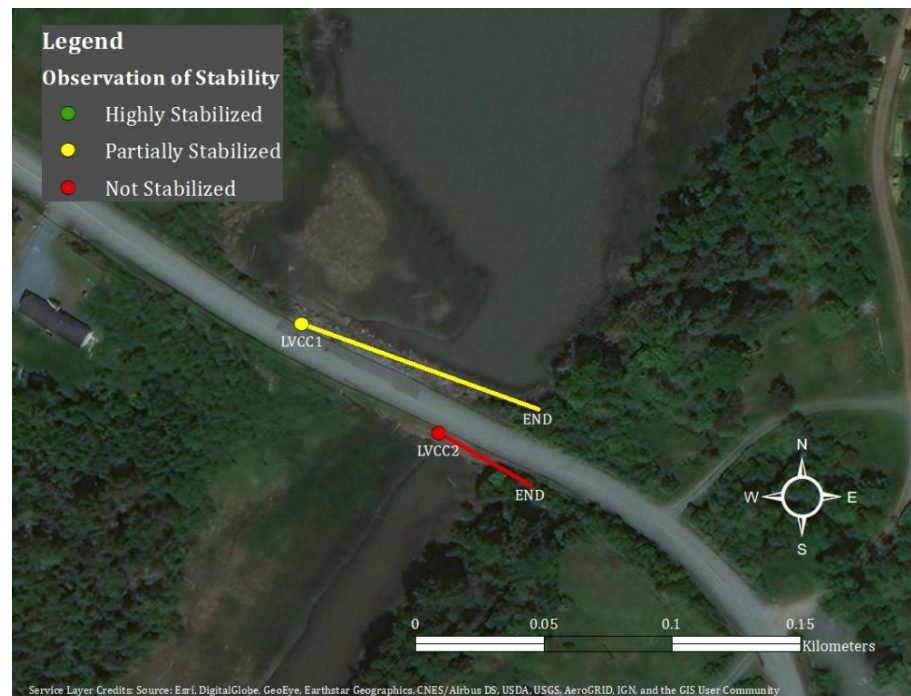
- Rock armouring is providing partially stability of LVCC1 (Figure 45).
- Buckling and cracking of the roadway is observed in both LVCC1 and LVCC2 (Figure 46B).
- The culvert in place at LVCC2 is blocked by organic debris limiting flow of water below the roadway (Figure 46C).
- LVCC1 is partially vegetated with grasses and few shrubs. LVCC2 has little vegetation present and is all grasses.
- Rock armouring is a combination of riprap and smaller rocks (Figure 46A).

Figure 45: Observation of stability at Lorneville Cove 1 at Lorneville Community Centre observed in summer 2021.

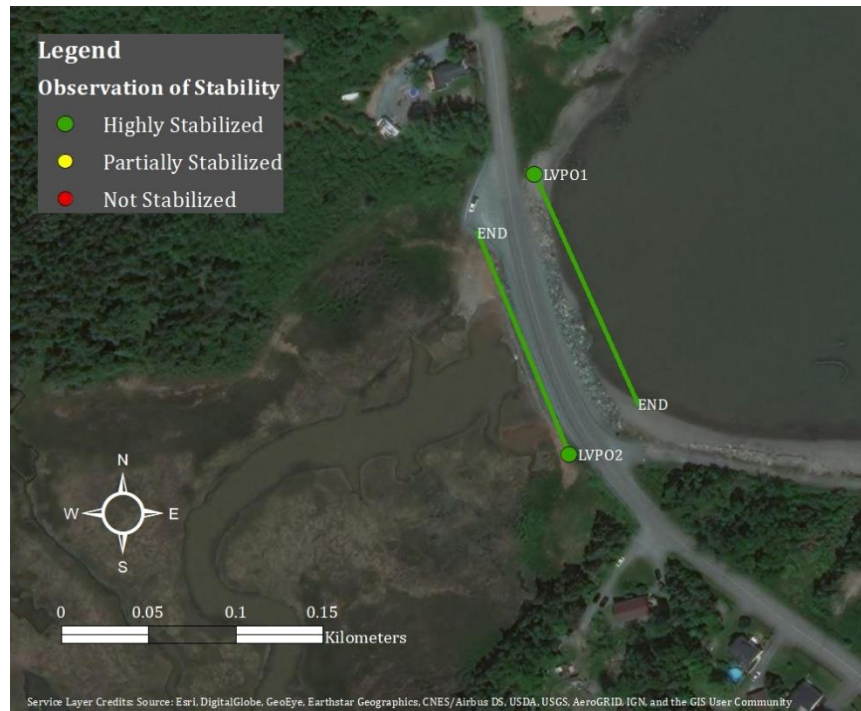
- Riprap is providing stability at both LVPO1 and LVPO2 (Figure 47).
- A large concrete culvert allows water to flow below the roadway (Figure 48).
- Updates made to infrastructure in the last five years.

Figure 47: Observation of stability at Lorneville Cove 2 at Post Office Road in summer 2021.

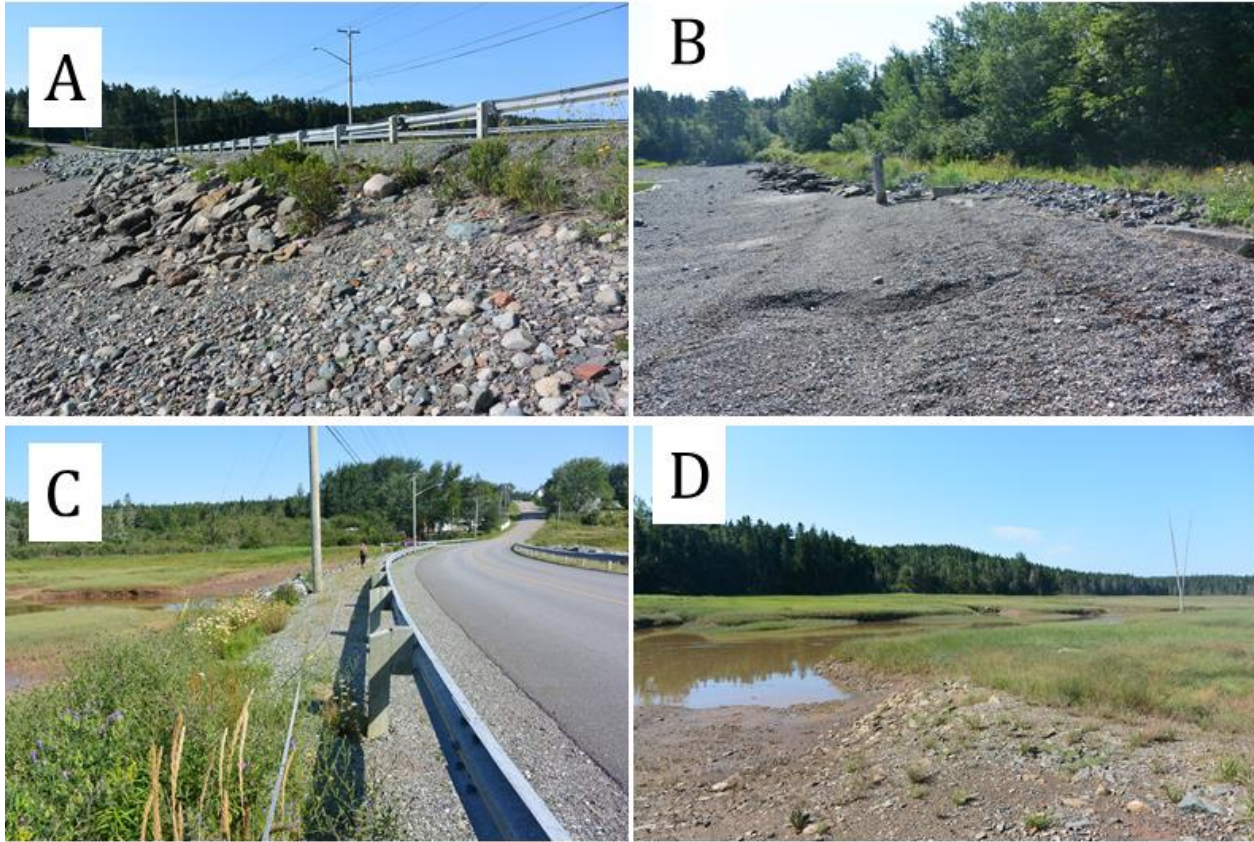
- No vegetation is observed on the slopes where riprap is in place, but grasses are present along the edge of the roadway before and after riprap (Figure 49A/C).
- Marsh observed inland of LVPO2 is vulnerable to coastal squeeze (Figure 49D).

Figure 49: Highlights at Lorneville Cove 2 at Post Office Road. (A) View from the start of LVPO1. (B) Beyond the roadway at LVPO1 where the coastline flattens out and vegetation is present. (C) View from the roadside at LVPO2. (D) Looking inland at LVPO2.
